# **Renovation and Reconstruction of Historical Buildings in Order to Improve Strength with Longibility: A case study of old Dhaka Central Jail**

A thesis submitted to the Department of Civil Engineering in partial fulfillment for the degree of Bachelor of Science in Civil Engineering

Sonargaon University

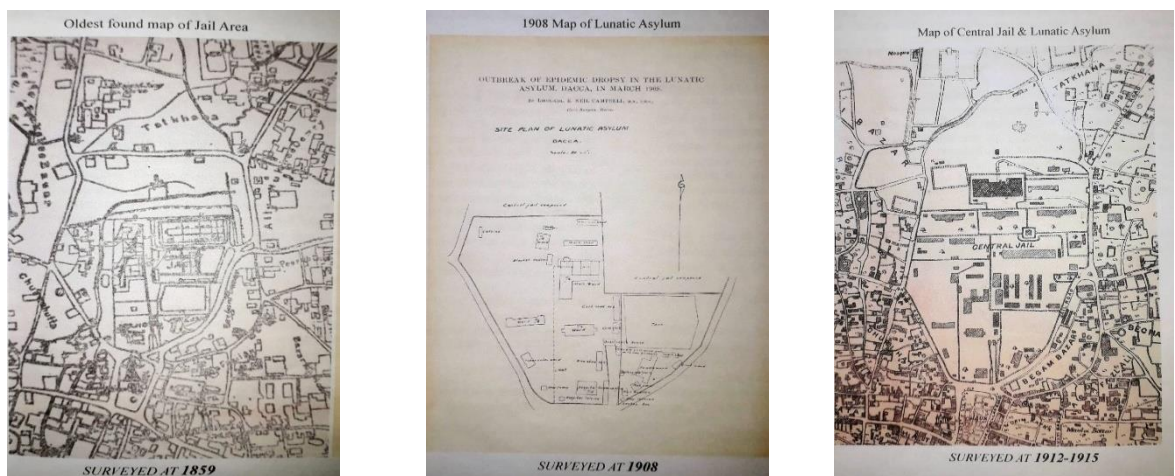
Fig 1.3: Historical Map of old Central Jail

According to Historians, 1545- The Afghan Fort (old fort) was built in the period of Sher Shah Shuri, an Afghan ruler. (Ref- Nana rong er Dhaka; P-82, Kajal Ghosh) [10] Later, Islam Khan rebuilt the fort in 1638. There was a palace, a court and a mint inside the fort. The maximum important public services were carried out there. In the tenure stated above, there was a mental asylum in the fort also. Up to 1772 in Mughal Dynasty, the fort was used solely as a mint. Around in 1810, the inhabitants of Old Dhaka had a movement against the impose of holding tax at the Fort Area. During Sepoy Mutiny in 1857, the Rebel Soldiers were the first to be disarmed by the English Soldiers. Later, During East-India Company Dynasty, the Fort was transformed into a Jail in 19th Century. At the same time Aligarh, Rajshahi Jail was also established. During Anti-British Movement, many activists were held at this prison. In 1948, Along with Sheikh Mujibur Rahman, some other leaders were held at Central jail that invoked people to burst out against the Ruling party. In 1966, Sheikh Mujib was again got prisoned and started the 6-term Movement that intrigued a mass involvement across the country. The Mass Movement in 1969, to free Sheikh Mujib from the central jail, a huge crowd was gathered outside the jail area.

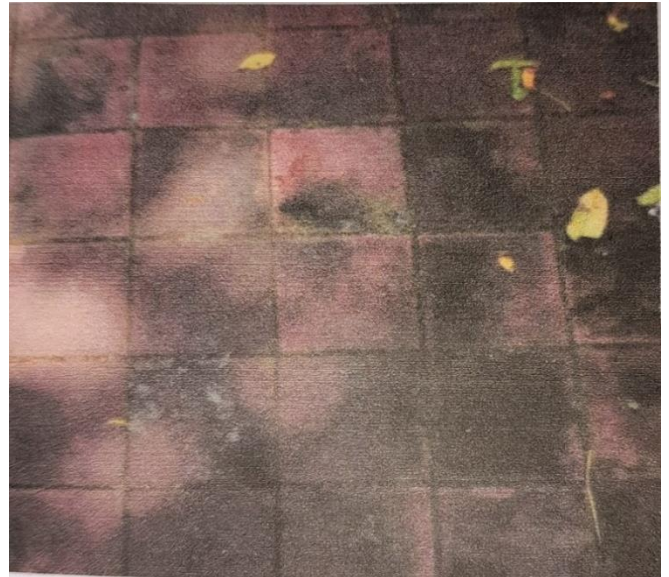
Existing paved tile will be replaced with brushed concrete surface.

Fig 4.1: Pavement of Bangabandhu Kara Smriti Museum Premise

A perfect sample of the then paved surface of jail area made of lime plaster and stone having a mild reddish tone.

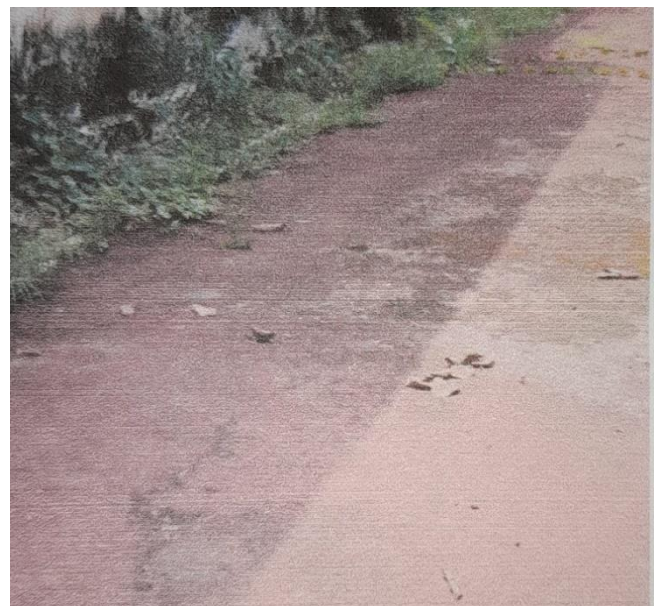
Fig 4.2: Pavement Beside Workshop 01

This material will be conserved and will work as a sample for other paved surfaces in the whole project.

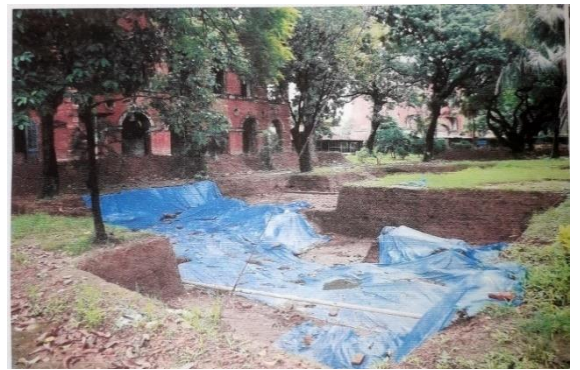
The old Dhaka central jail has a history of more than 400 years, from Pre-sultanate period. It was named as afghan fort. The British demolished several parts of it and made it Dhaka jail. The trace can be restored only through proper archaeological excavation.

Fig 4.4: Archaeological Excavation Areas

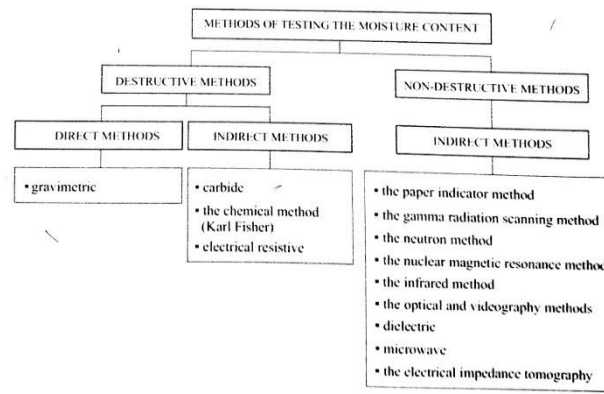
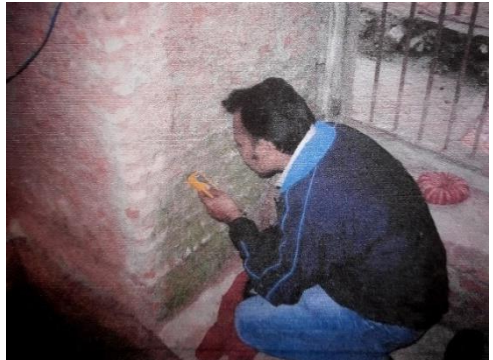
Fig 4.5: Methods of Testing Moisture Content of Bricks Wall

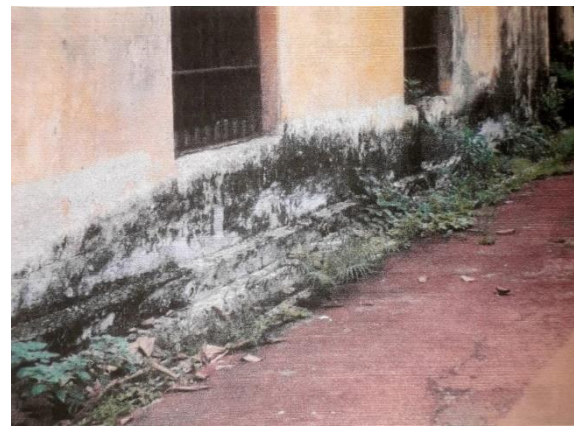
For brick walls in historic buildings, the consequence of long-term moisture, usually combined with excessive salinity, is the severe and extensive destruction of wall components. At the beginning of the restoration works of such objects, specialized tests of the moisture content should be first executed. If the moisture content in walls exceeds the permissible level, it is necessary to undertake measures for its reduction. In the conditional survey, presence of moisture in the form of dampness is present in several buildings; this is due to rain penetration, drainage issues, damp from the land.

Figure 4.6: Salt crystallization in different areas in Old Dhaka Central Jail Compound.

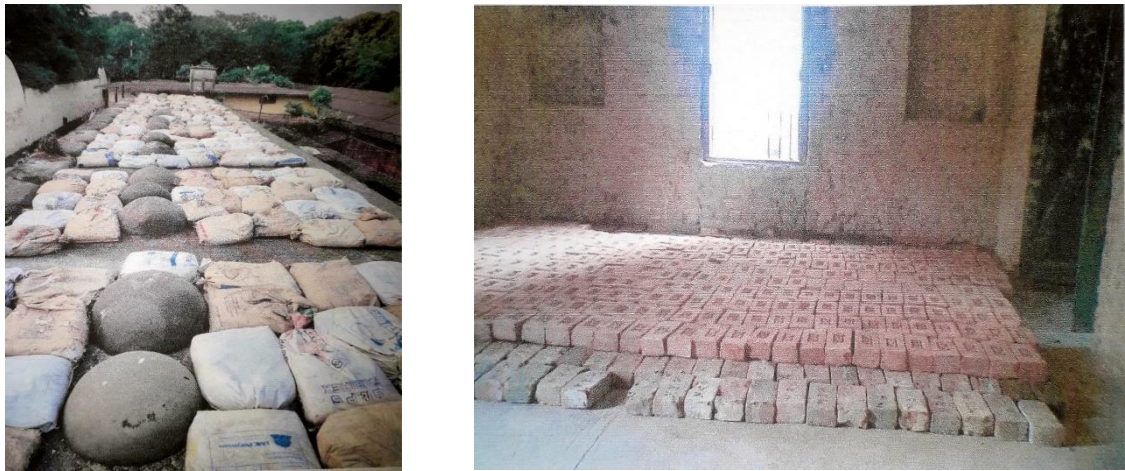
Fig 4.8: Slab Strength Analysis: Brick Laying/Sand Bag Test

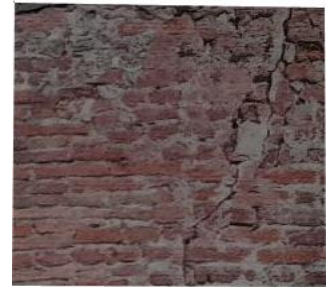
Thick work is damaged, it might not be just blighting buildings appearance: it could also be letting more moisture penetrate the er or outer walls or even compromising the wall's structural integrity.

Fig 10: Damaged Bricks

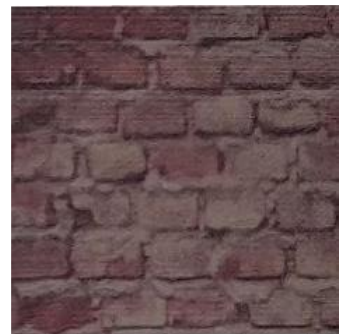
The brickwork might have been pointed in a manner that has led to the wall inadvertently picking up damage. For example, modern cement mortar instead of traditional lime mortar - has been used for pointing. The more modern mortar could trap moisture and so prevent it escaping via the mortar joints. This, in turn, would force the moisture to emerge on the brick faces, where it could be frozen and then lead the brick surfaces to crumble.

Fig 11: Unsuitable Pointing

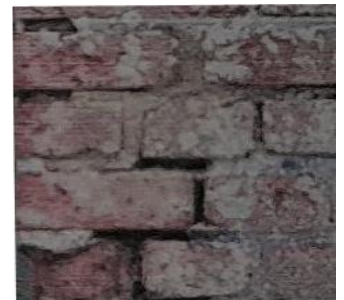
It refers to white deposits that form on brickwork due to water including dissolved salts rising to the surface. Efflorescence does at typically damage the brickwork from a practical point of view. However, it is unsightly and if the way that the brickwork has been assembled is causing efflorescence, then replacing that brickwork might be the best solution.

Fig12: Efflorescence

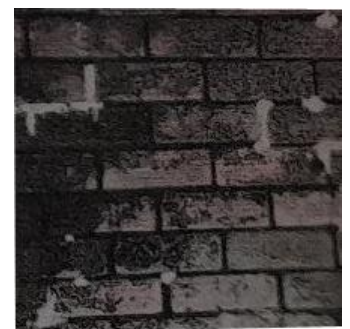
Decaying timber flooring or crumbling plaster can indicate damp. Alternatively, it might be penetrating damp, which can happen if water shifts from a high part of your home to another part further down. An especially common cause of penetrating damp is inadequate pointing to the brickwork. Such pointing can let water leak into the wall.

Fig 13: Damp

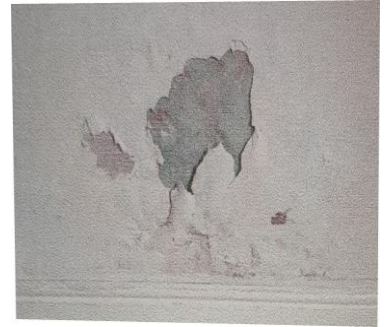
- Remove the damped/ distressed plaster
- Rake out the joint mortar - clean this exposed surface properly and repack using seal coat after layer.

Fig 14: Damped Plaster

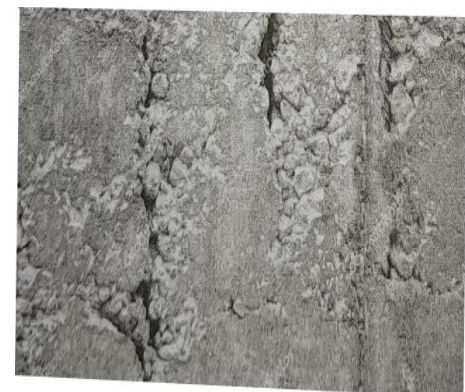
Fig 16: Honeycombed Concrete

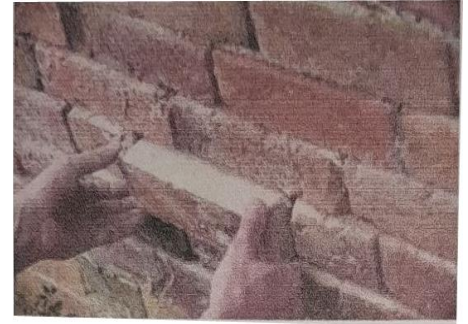
Brick walls are typically durable. It can withstand severe weather and other abuse for years. But they are not impervious to erosion. Brick and mortar expands and contracts as moisture enters and evaporates. Over time, the natural expansion and contraction of the brick caused by water infiltration causes erosion or crumbling of the mortar.

Fig 17: Decayed Bricks in Wall

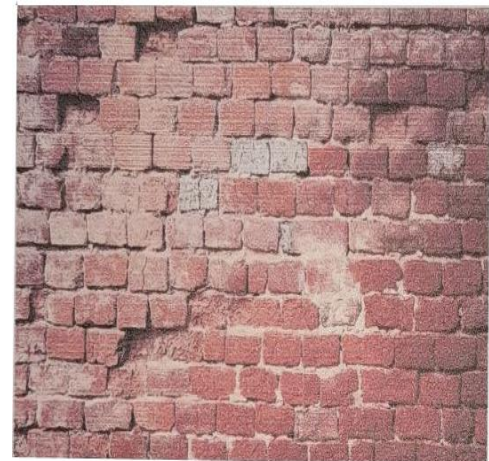
Spalling is when brick masonry begins to deteriorate to the point chunks of brick are falling from the structure. Spalling starts off as small cracks that grow into bigger cracks until the entire surface deteriorates it's a indication that the surrounding bricks will do the same.

Fig 18: Palling Effects of Bricks

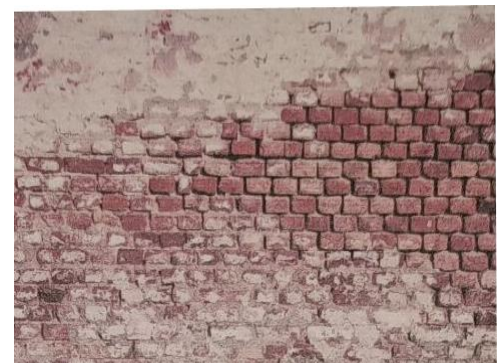
In old building there are lot of cracks.

Fig 19: Cracks in Brick Wall

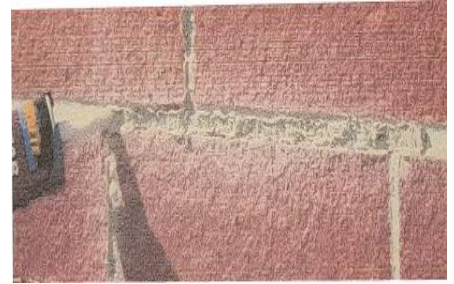
Eroding bricks can be repaired by patching over the old mortar without removing, the crumbling sections. This process is called tack pointing. But it is not a long-term repair for eroding brick walls. Tuck-pointing eroded joints provides a weak bond between old and new mortar layers.

Fig 20: Patching in brick wall

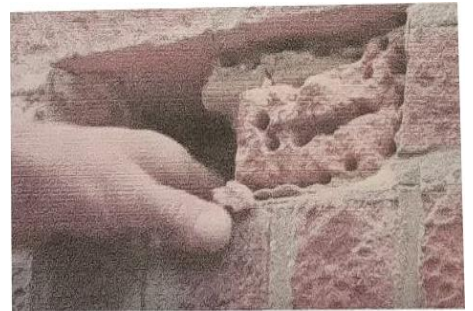
Damaged joints need to be dug out at least as deep as they are wide. The loose mortar needs to be removed by sliding a grout saw between the horizontal joints and digging out the crumbling sections to a depth of at least a 3/4 inch.

Fig 21: Damage in Brick Wall

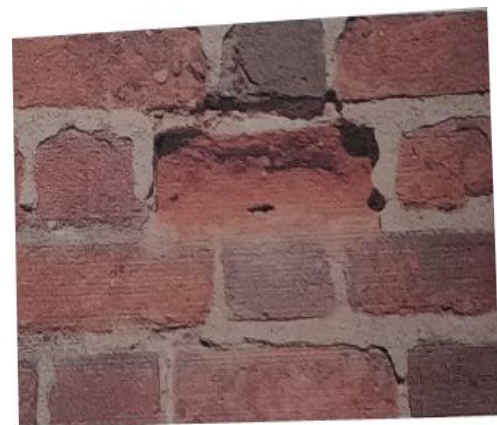
Bricks that have spalled tend to make the penetration of moisture more likely, look unsightly and may have structural implications for the wall. There are a number of options available to rectify the problem.

Fig 22: Damaged Bricks

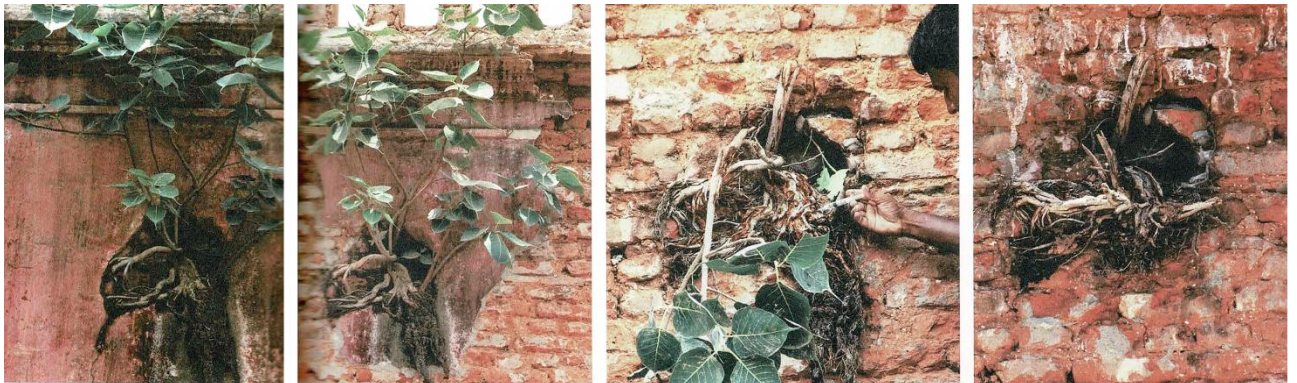
- 2.1 All surfaces around the banyan tree needs to be de-plastered
- 2.2 If the root is of a reasonable size, drill holes into the stumps 80mm deep and fill the approved herbicide solution. Soak acid free paper pulp in a solution of ammonium carbonate (GPR) 5% - 8% / Sodium Arcenite, mixed with distilled water and cover the affected areas.
- 2.3 Wrap/ cover the area with polythene and keep it for about 4-5 days.
- 2.4 Remove the polythene cover and spray the solution given under 1.0 using a hand spray to wet the dried paper pulp and wrap/ cover the area again with

Fig 4.24: Strangler Fig Plants or Trees in Building

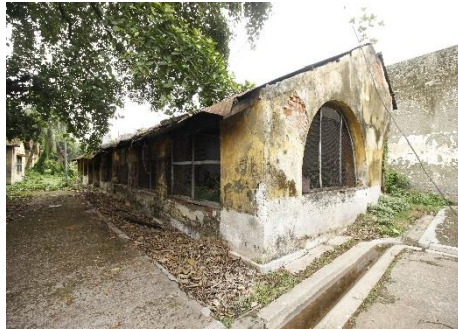
Fig 4.25: Existing Wall Condition

1. Walls shall be treated with a slow-release copper biocide with a pH of 7 or above - the contractor shall propose the product to be used for the approval of the consultant.
2. Provide complete protection against breakage, staining and weather damage (mainly due to sun and rain) by temporary cover, but with adequate ventilation.

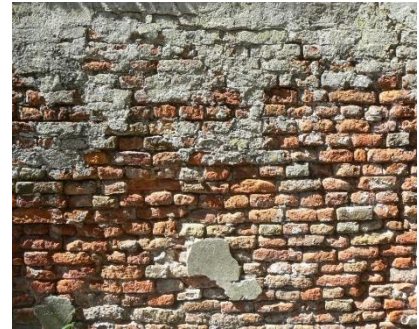
Fig 4.26: Reference Image of Wall after Cleaning Lichen/Algae Growth.

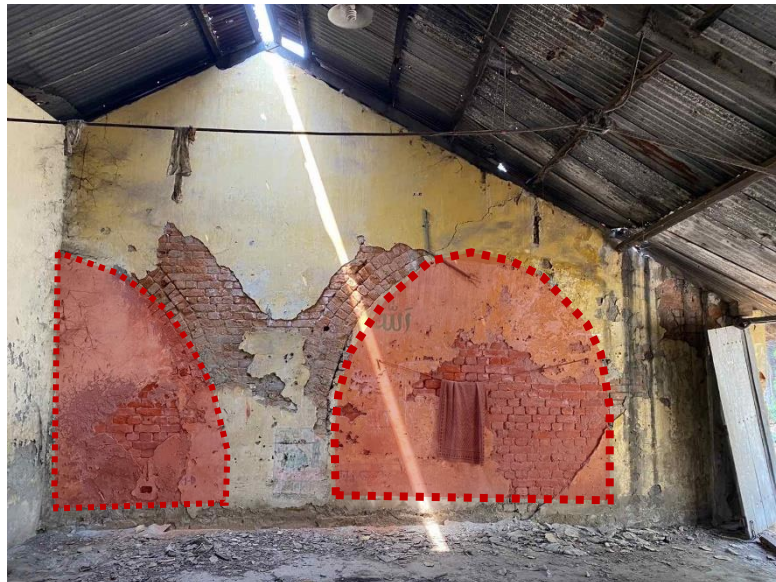
Fig 4.28: Arched opening revitalization from CP05

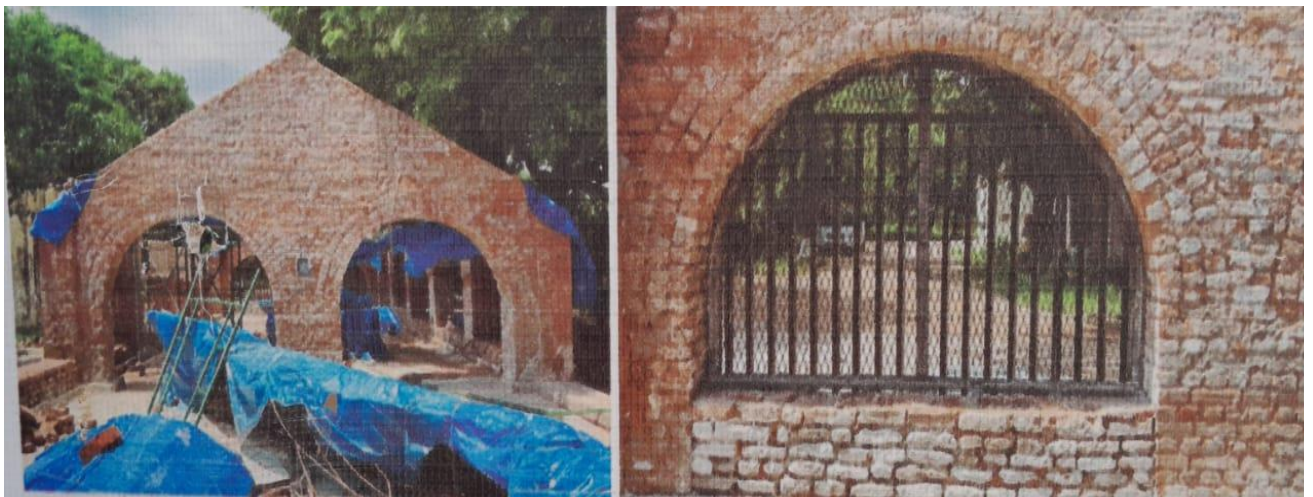
During the last restoration work occurred in Jail, lime plasters used in all internal and external surfaces are mostly removed and re-plastered with cement mortars. The use of cement mortars as plaster is widely recognized as being detrimental to old buildings as they can drastically alter the way in which a wall handles water and water vapors. Cement mortars tend to trap water which will lead towards dampness, and mortars may ultimately fail, often causing damage to the surrounding masonry in the process. So all cement plasters should be removed from CC 05, CC-06, CC-07, CD-25, CD-26.

However, De-plastering shows all the defects and cracks in the walls to come up with intervention plan. Lime and Surki are the main ingredients used in the construction system in the Jail Compound.

Fig 4.29: De-Plastering

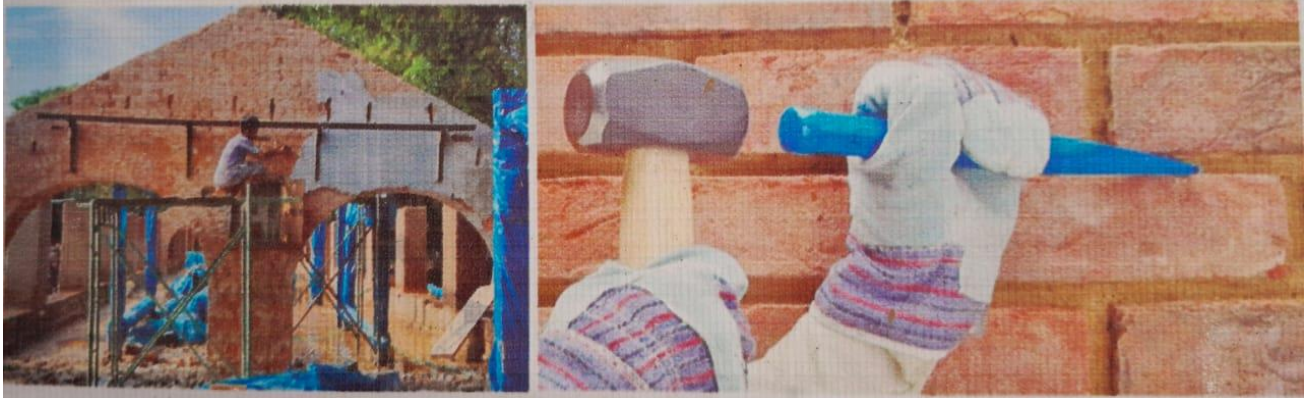
De-pointing-Removal of Damaged Brick Face and Joint carefully. After the de-plastering, Cement mortar will be removed. The joints on the exposed surface shall be carefully raked with soft stick or pointing key to a depth of about 8mm, or at least twice the width of the joint.

Fig 4.30: De-Pointing

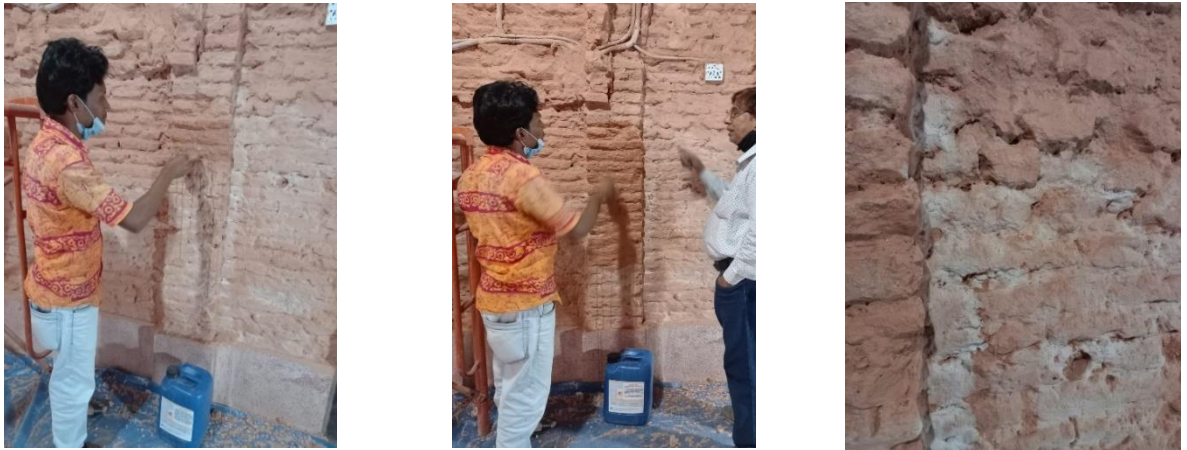
1. The plaques or molded bricks to be removed for destination shall be agreed with the consultant.
2. A detail drawing shall be prepared showing the inception of the plaques/molded bricks to be re- moved so that they can be correctly replaced following treatment.
3. The plaques/molded bricks shall be placed in a clean container filled with distilled or deionized.
4. Immersion should be continued over 10 days, with the water being changed 5 times during that period.
5. At the conclusion of the process, any sediment that may have accumulate on surfaces during desalination should be removed with a small amount of clean distilled/deionized water.
6. The plaque/molded brick should be placed to dry in a position and at an angle which allows water.

Fig 4.31: Reference Picture of Conservation project

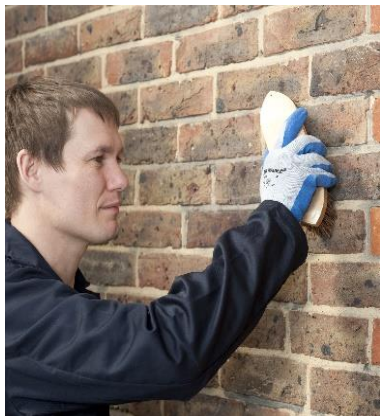
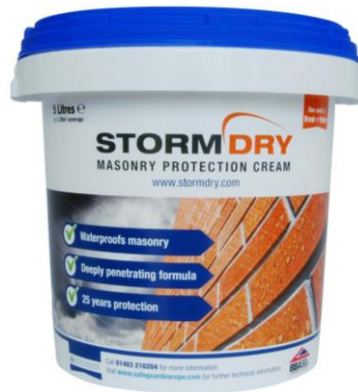
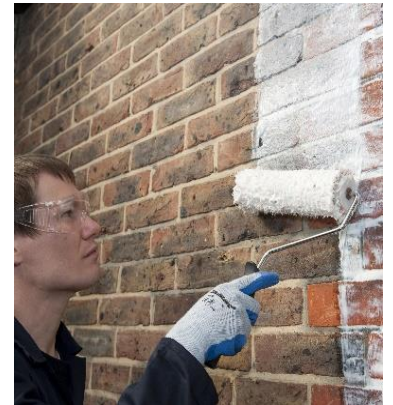
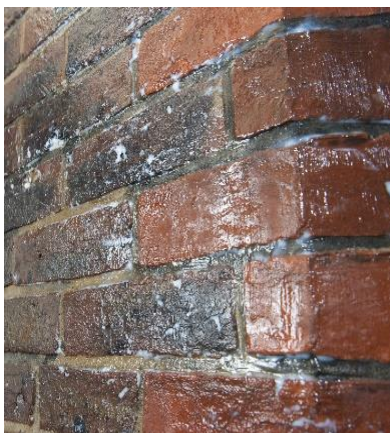
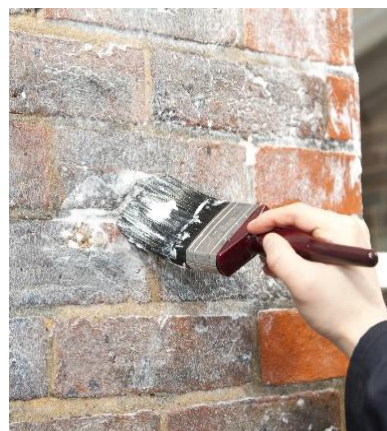
Fig 4.32: Damp Proofing Works

01. Tamarind solution (1 kg tamarind with 10 ltr water for 150sft surface)
02. D-Salt, SBR & Foam-Lub

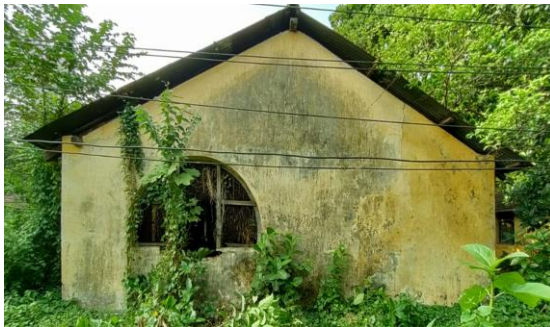
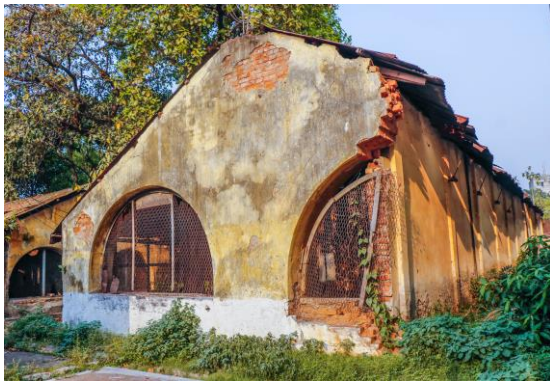
Fig 4.34: Repairing the cracks with field condition and repair system.

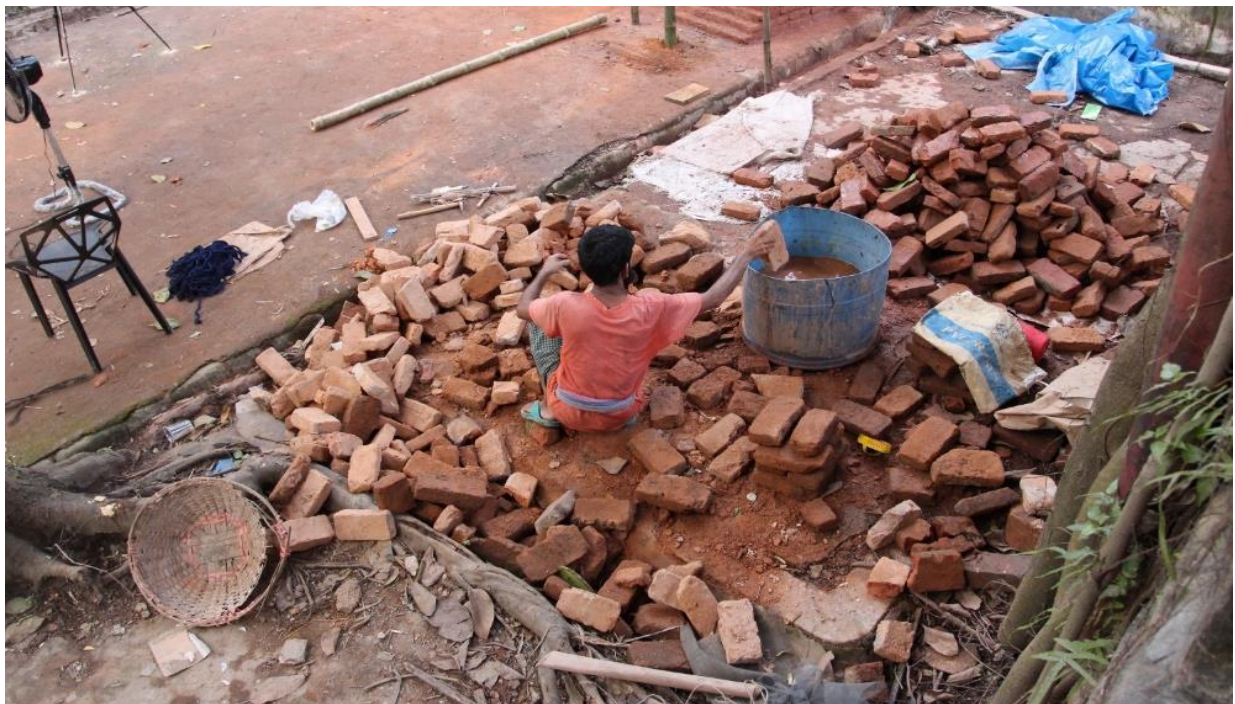
Fig 4.35: Reclaimed Brick Works

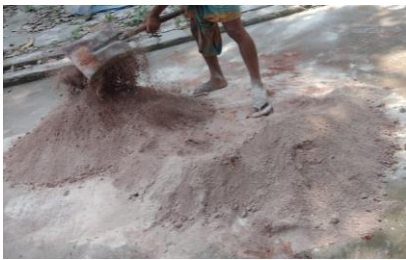
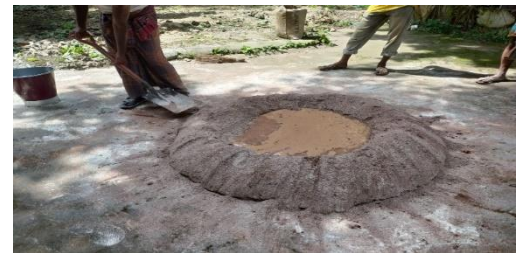
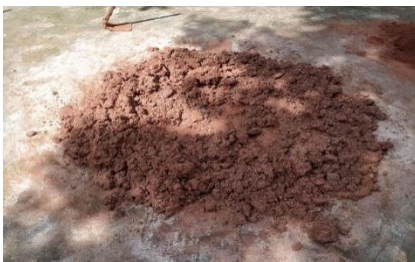
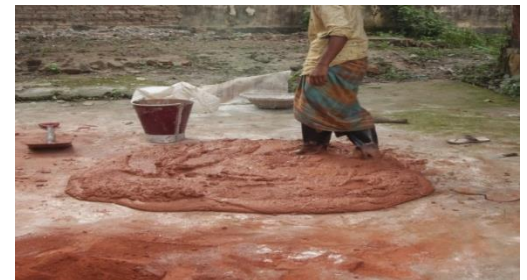
Fig 4.36: Preparation of Lime Surki Mortar

Binder: Brown Sugar Molasses (Chitagur)

For 1 cft (12-15 kg) of Lime, 1 tbsp (12/15 gm) of Brown Sugar is enough to ensure desired bonding.

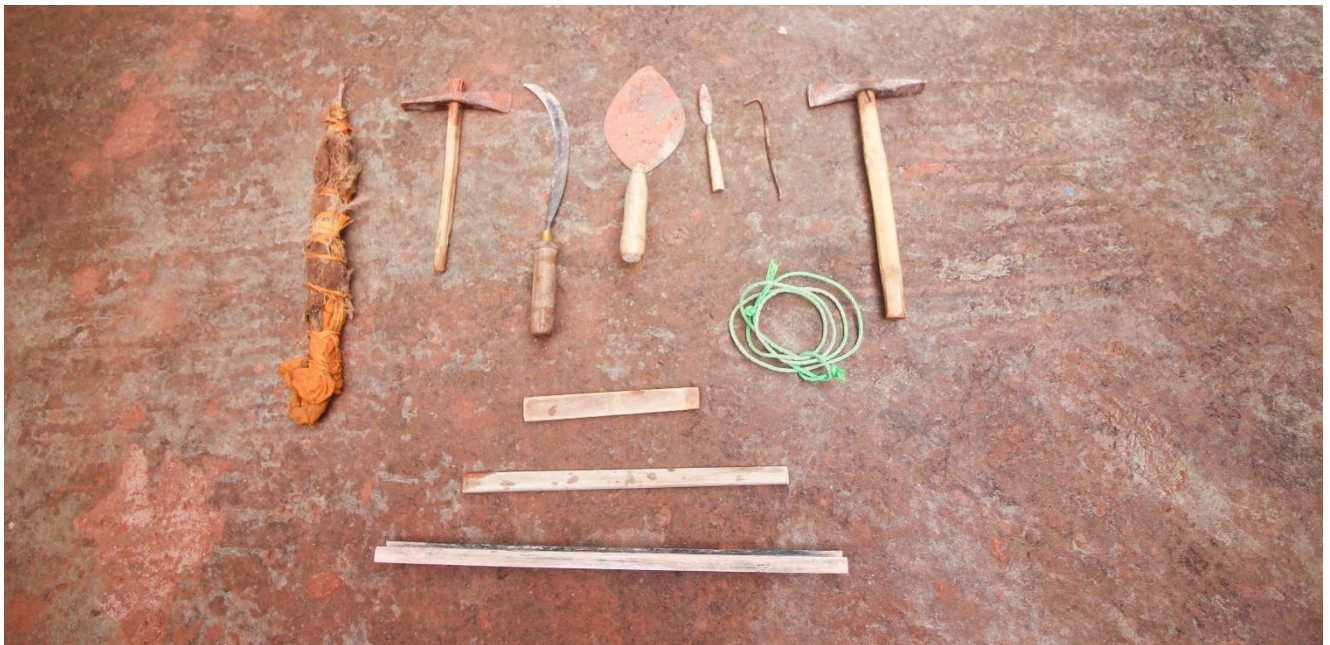
Fig 4.38: Repointing Tools

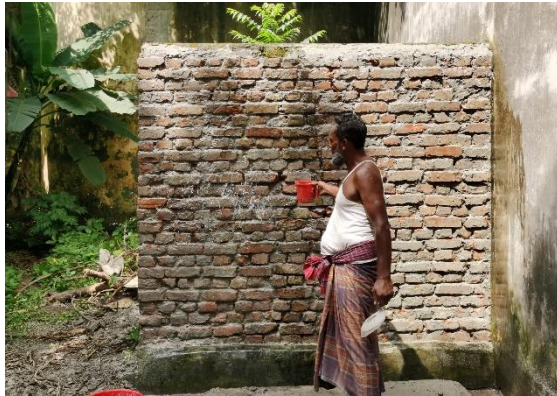
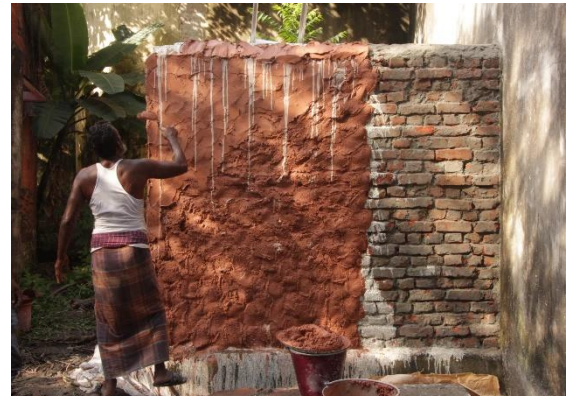
1. Spreading water to clean the surface and chemical to prevent bio-deterioration.
2. Using lime water over the wet surface as the binder for lime plaster.
3. Then mortar has been placed in small portions.

4. Spread the mortar through the wall with wooden darby . After spreading the mortar, the wall has been kept to dry for 6 hours.
5. Using hammer to compact the surface and to remove the air bubble among the surface.

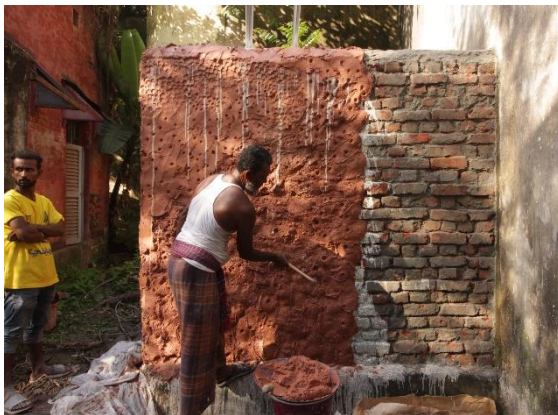
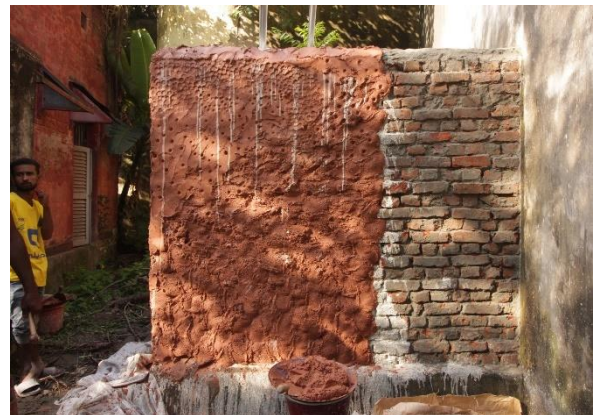
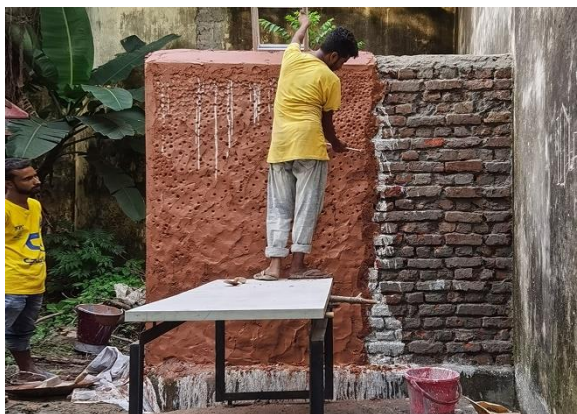
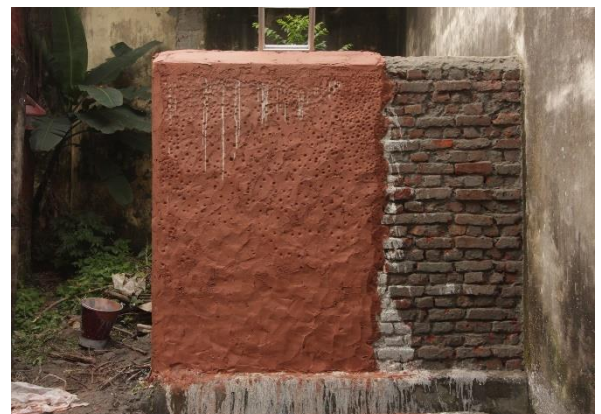
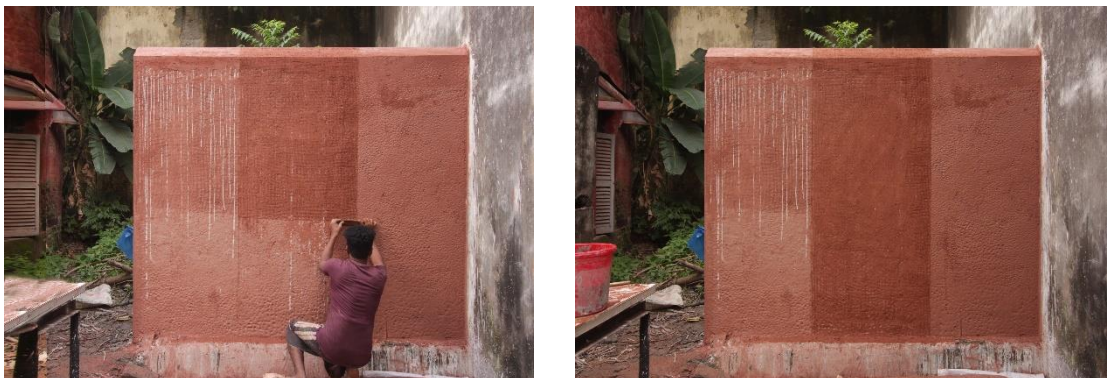
Fig 4.42: Lime Surki Plaster Process

6. Using hammer to compact the surface and to remove the air bubble among the surface.

- Using hammer to compact the surface and to remove the air bubble among the surface.

- Finishing with clean like lime mortar, using steel trowel for smooth surface finish.

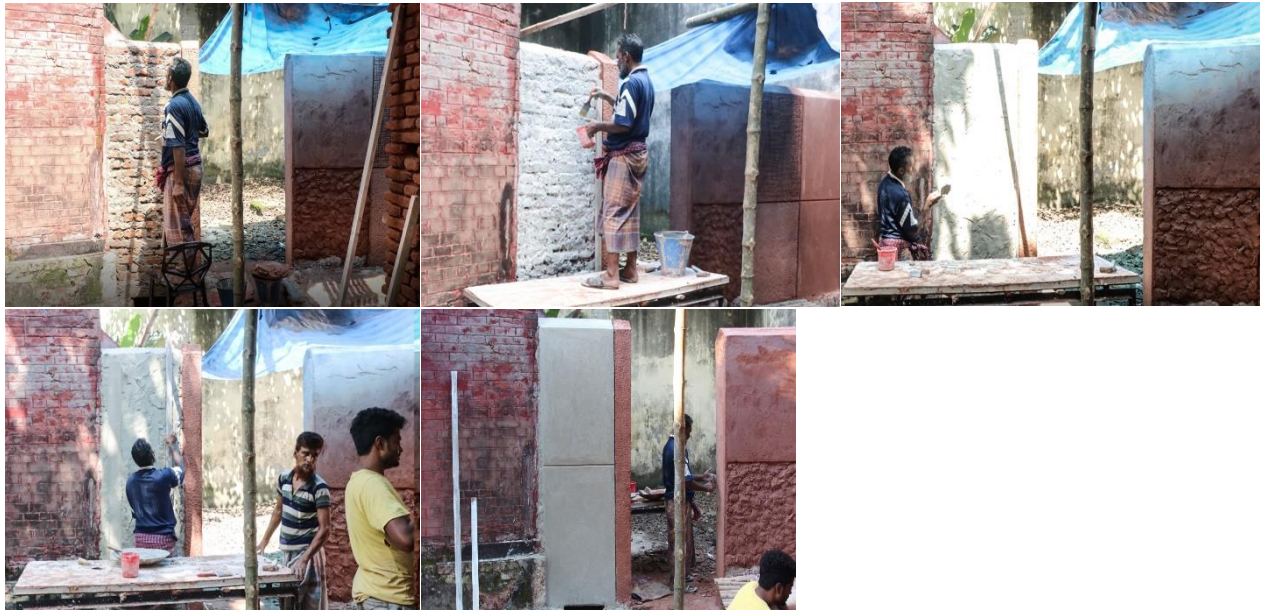
1. Spreading water and Chemical for prevention against bio deterioration .
2. enhance the quantity of moisture by using lime water
3. Lime sand mortar placed on the wall in small portion
4. Spread over the wall for uniform distribution by wooden Darby .
5. Finished with lime wash .

Fig 4.44: Lime Mortar Process

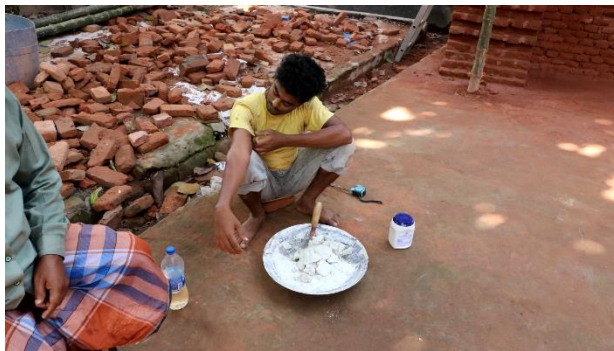
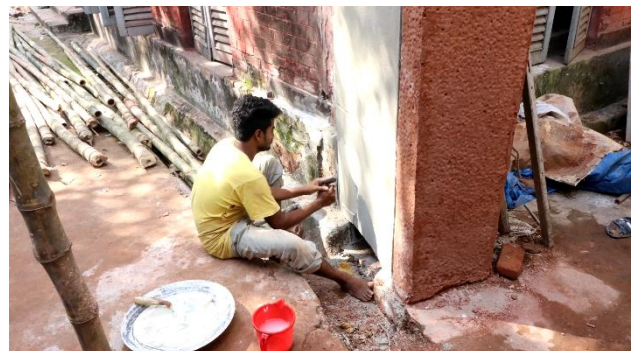
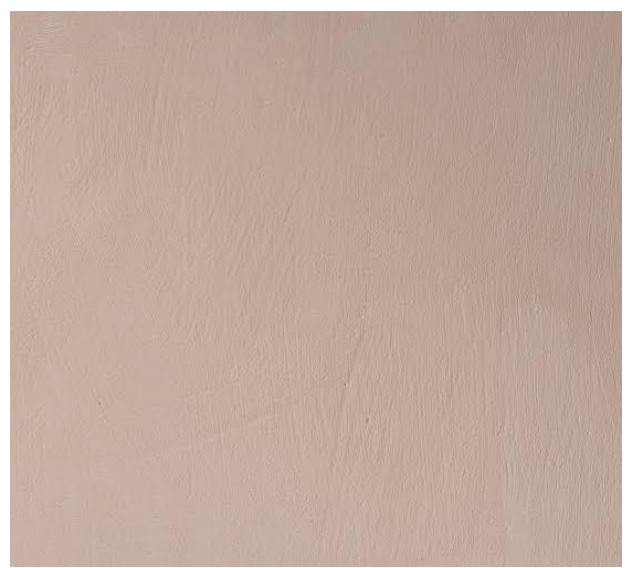
Fig 4.45: Lime Washing Work

5.2. Each coat shall be perfectly dry before the succeeding one is laid over it.

5.3. In case of colored lime wash, priming coat shall be white

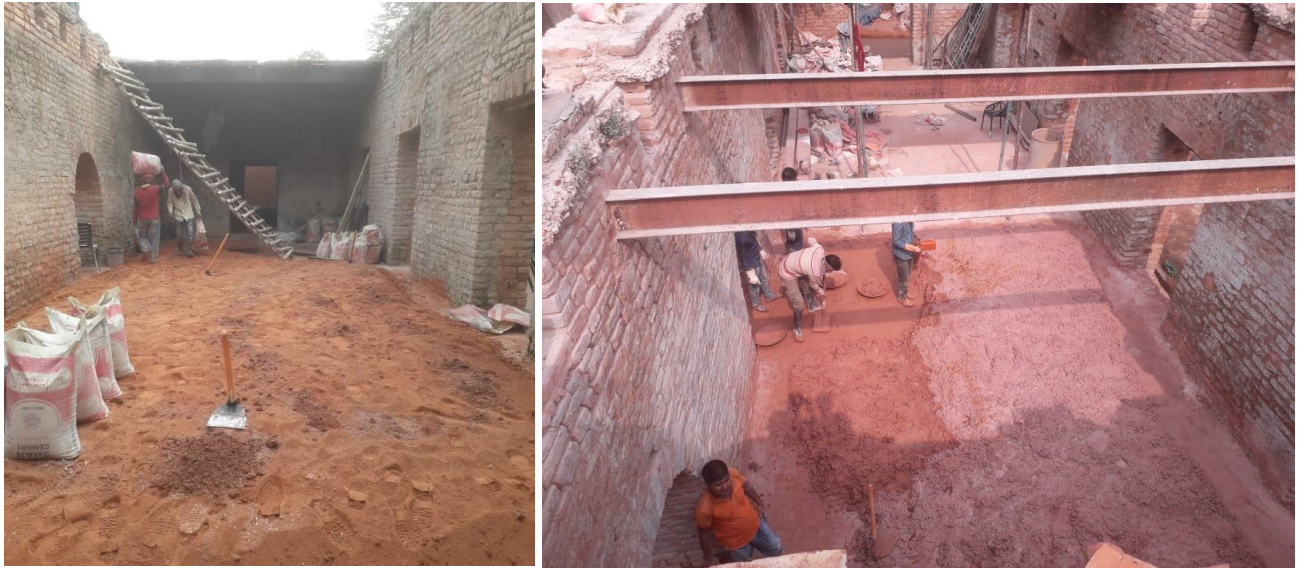
Brick Aggregates (khoa): Brick Dust (surki): Lime 7:2:2, Brick Aggregates (khoa) size 20 mm downgraded 1st class brick, Brick Dust (surki) good quality second class brick for Foundation Bases, Load bearing walls, Pavements, flooring etc.

Fig 4.46: Lime Concrete Mixing

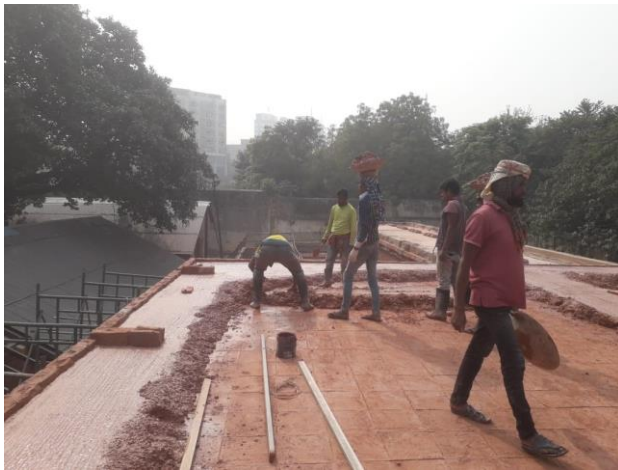
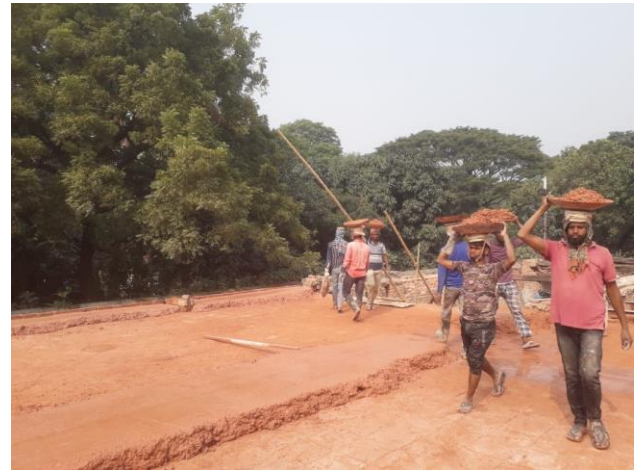
Fig 4.47: Lime Terracing

Lime Terracing Average 100 mm thick Finished lime terracing with 20 mm downgraded good quality second class brick chips (khoa) Surki from good quality second class bricks and minimum lime content 500 kg per 2.83 cubic meter Stone lime brought at site, not being powdered in open air and to be slaked in presence of Engineer-in-charge and to be measured in volume three days after slaking for using in the mix) in the proportion 7:2:2 (brick chips: surki: lime)

Including preparation of the mix on the ground by melding a suitable platform under proper polythene cover, cutting the mix twice dally with limewater (1:10) at least for 7 days until the mix attain Desirable consistency Laying the mix in proper slope, beating the same with standard koppa' (weighing more than 2kg) for minimum not 7 days to gain maximum consolidation, making ghoondy and neat finishing with Time Surki mortar (1:2) and curing for 21 days providing polythene cover after each day work and cleaning etc. complete in all respect accepted by the concern authority.

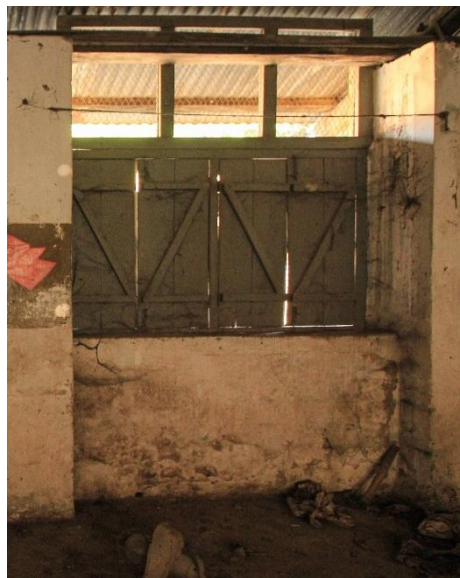
- Preservation
- Reconstruction\_ Doors and windows will be reconstructed as the number of openings has been increased in a greater extent.
- New Intervention\_ CC-06 windows from middle part will be replaced with glass doors.

Fig 4.53: Drawing of Existing Window Condition\_CC06

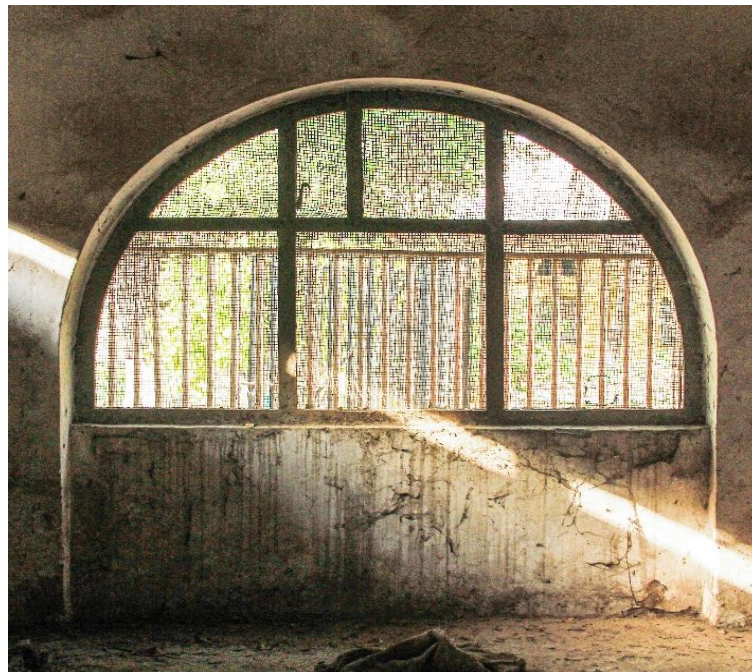
Fig 4.54: Existing Window Condition of CP-05

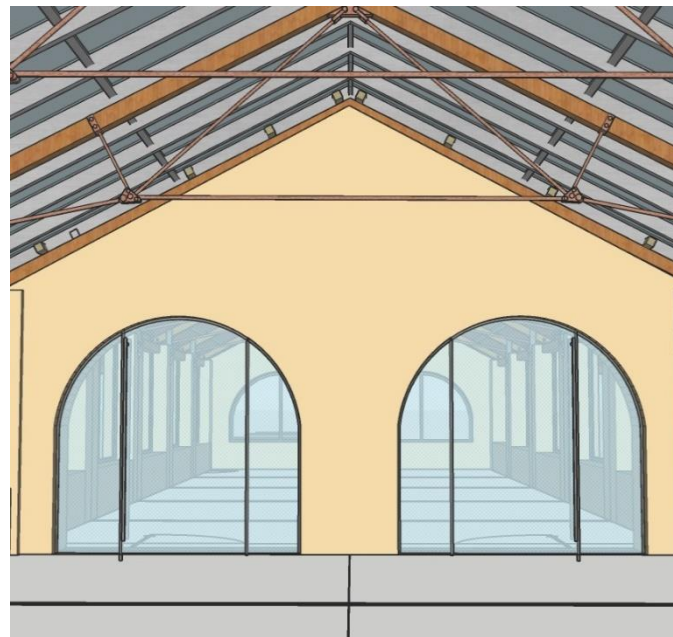
Fig 4.55: Proposed Window Condition of CC-05
