SONARGAON UNIVERSITY (SU)

Project and Thesis

AGEING IMPACT AND CRACK STUDY OF UNREINFORCED BRICK MASONRY STRUCTURE AND ITS REMEDY

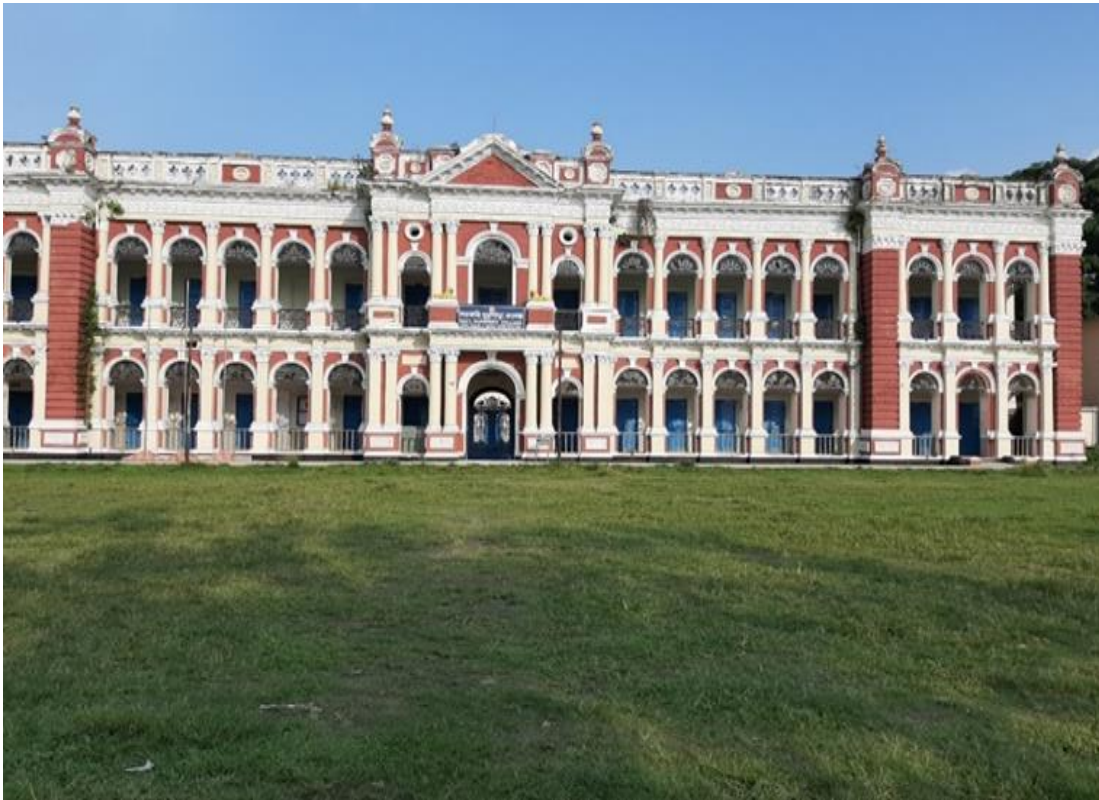
Figure.4.1: Front view of the college.

Possible Cause of Failure: Observing the crack it can be predicted that, due to the long-time perpetual loading, an uneven lime masonry settlement has been occurred. Hence a settlement failure developed.

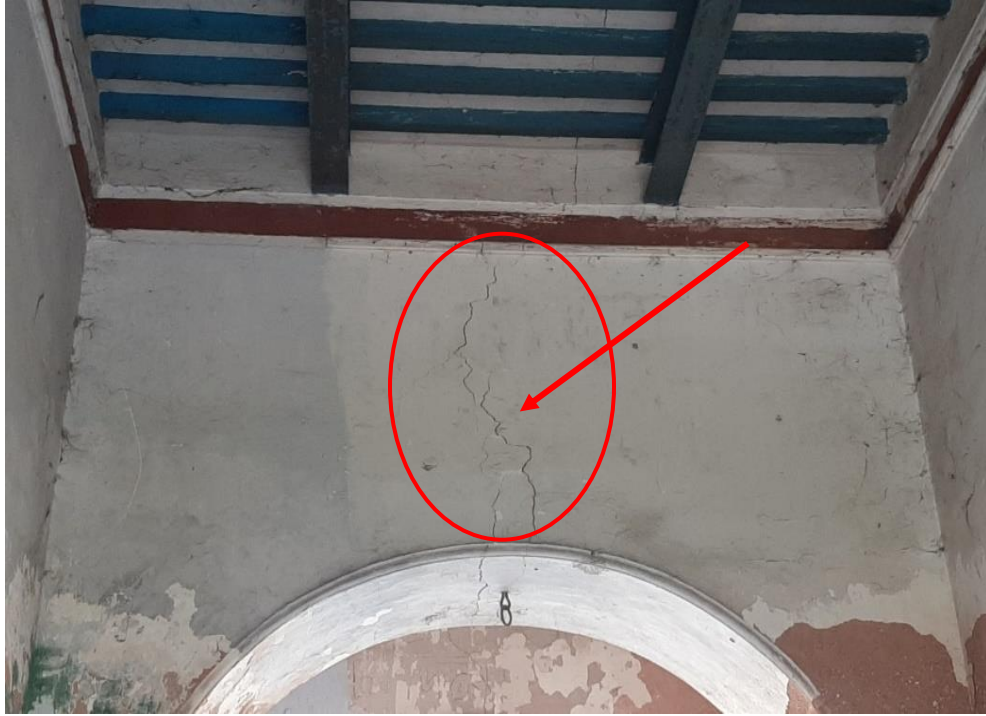
Figure. 4.2. Picture of arch crack

A roof to arch crack was observed. The crack is almost vertical along the brick sides. The crack even propagated below the arch.

Kinds of Failure: Settlement failure.

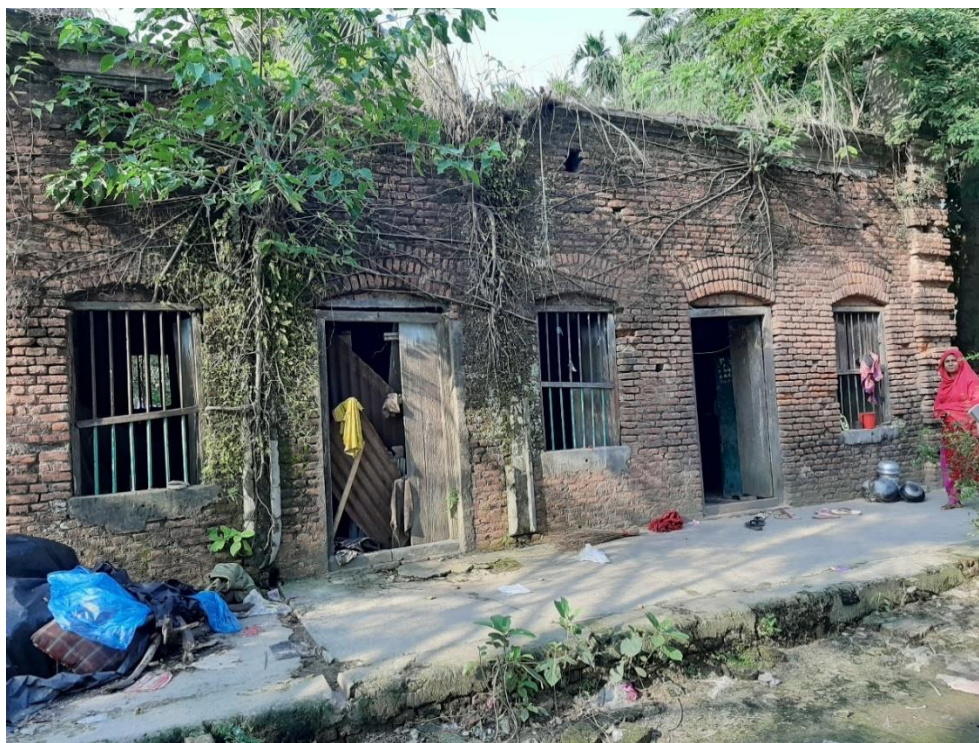
Figure.4.3. Old Jomider bari.

Possible Cause of Failure: Observing the crack probable cause of the failure due to weak bonding of lime masonry. That was the cause of bond failure.

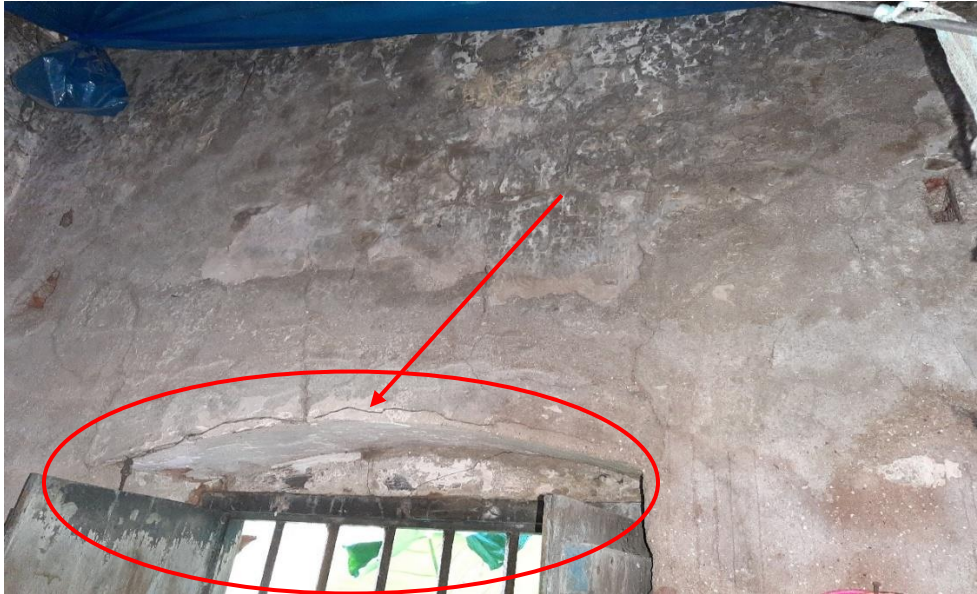
Figure.4.4. lintel joint crack

A roof to lintel crack was observed. The crack is almost horizontal along the concrete joint.

Kinds of Failure: Bond failure.

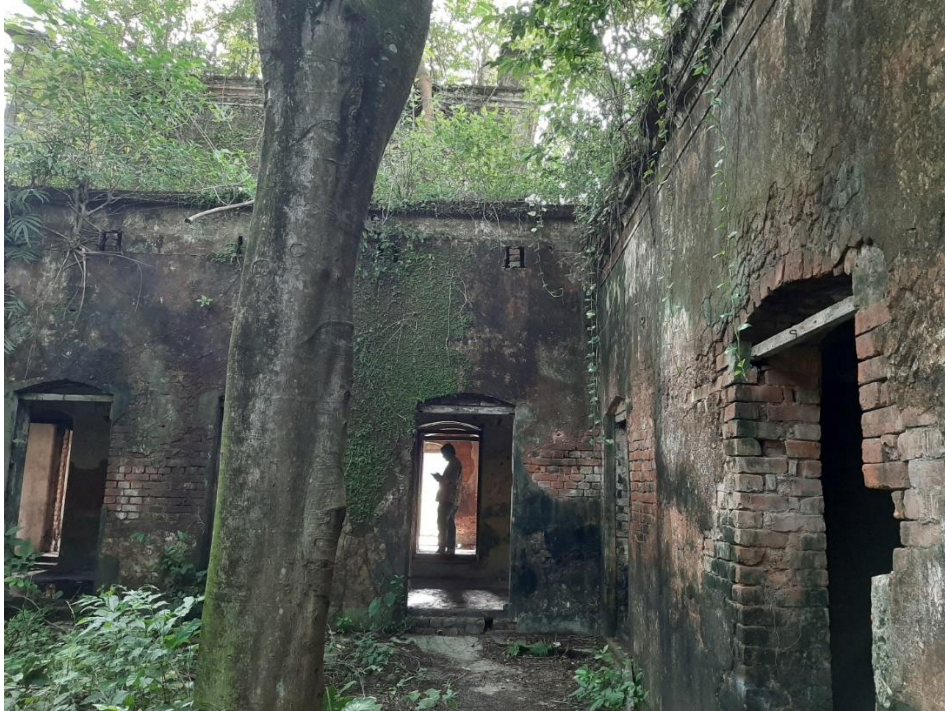
Figure.4.5. Old jomider bari-2.

Possible Cause of Failure: Observing the crack probable cause of the failure due to weak lime masonry settlement. That was the cause of settlement failure.

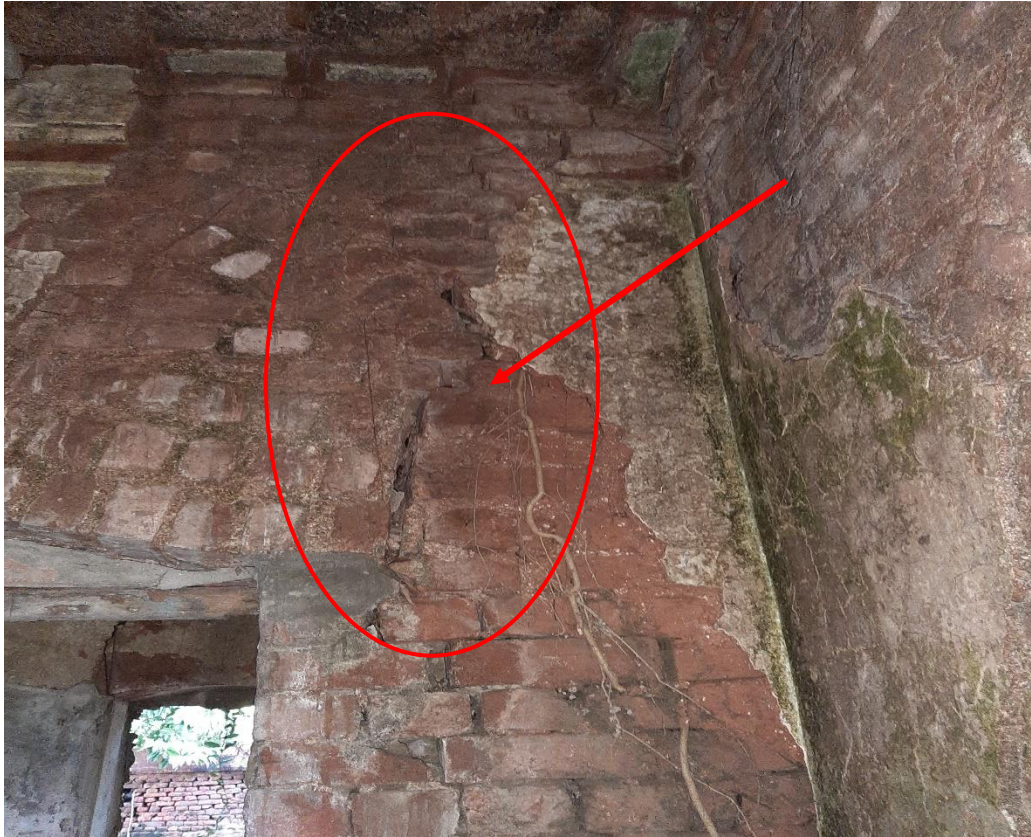
Figure.4.6. Vertical crack of wall.

A vertical crack of wall was observed. The crack is almost vertical along the masonry joint.

Kinds of Failure: Settlement failure.

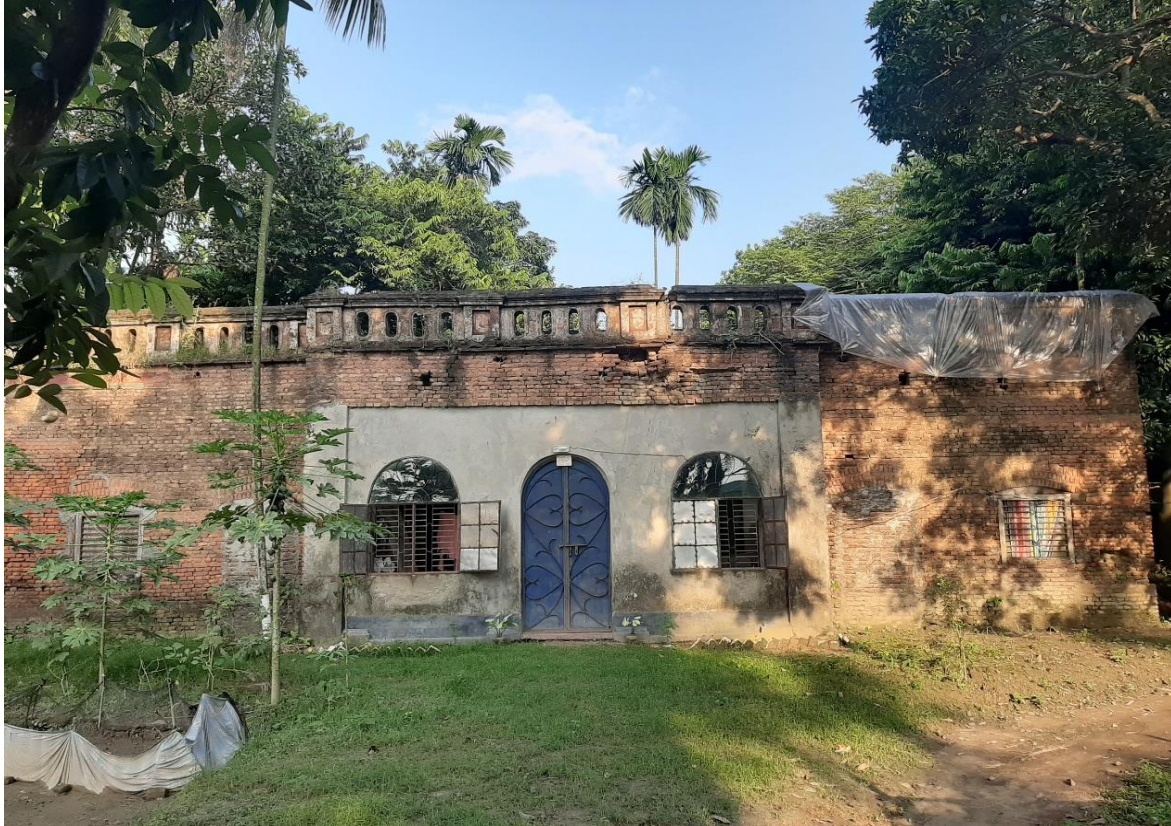
Figure.4.7. Front view of the building.

Possible Cause of Failure: The probable cracking defects in structural masonry seem to be associated with ground movements (settlement of soil), although defects like expansion/shrinkage of masonry materials or thermal movements can also occur.

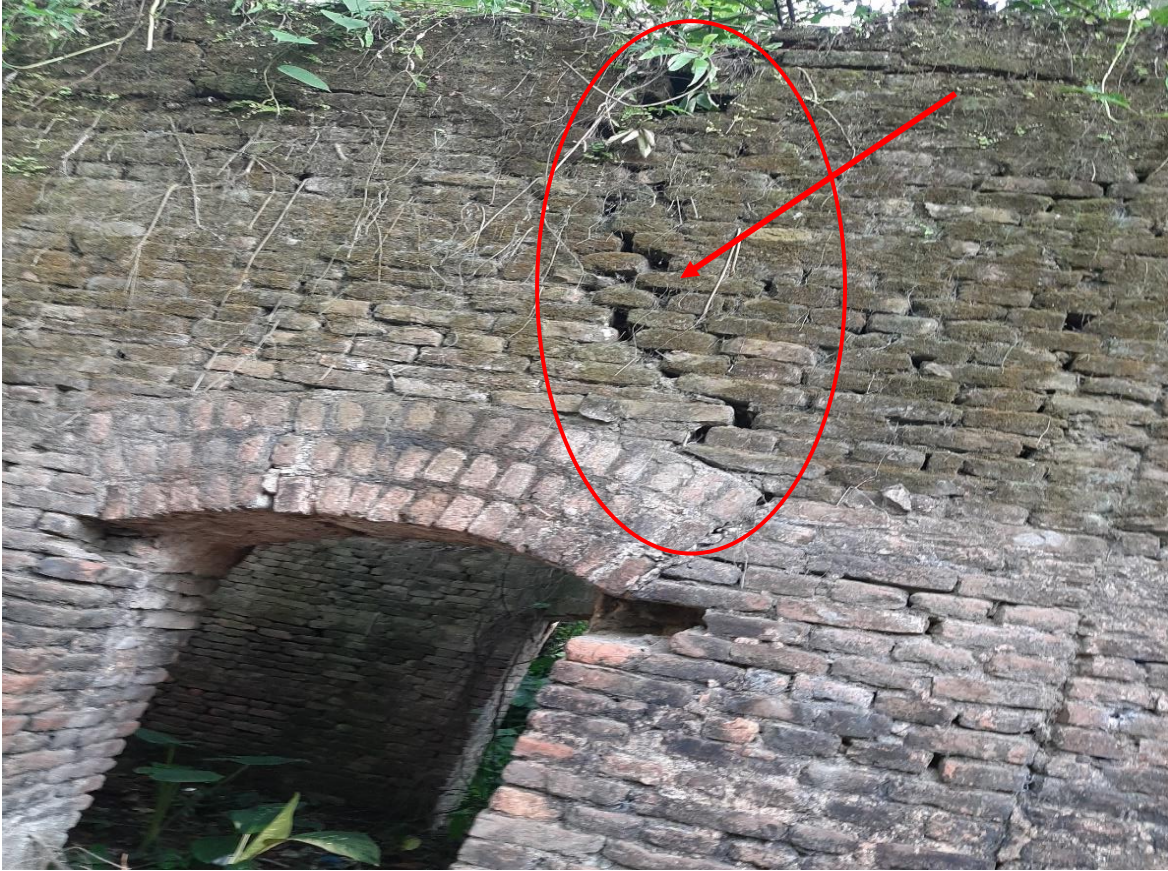
Figure.4.8. crack on due to differential settlement of structure.

A incline/angler crack of wall was observed. The crack even propagated over the lintel.

Kinds of Failure: Settlement failure.

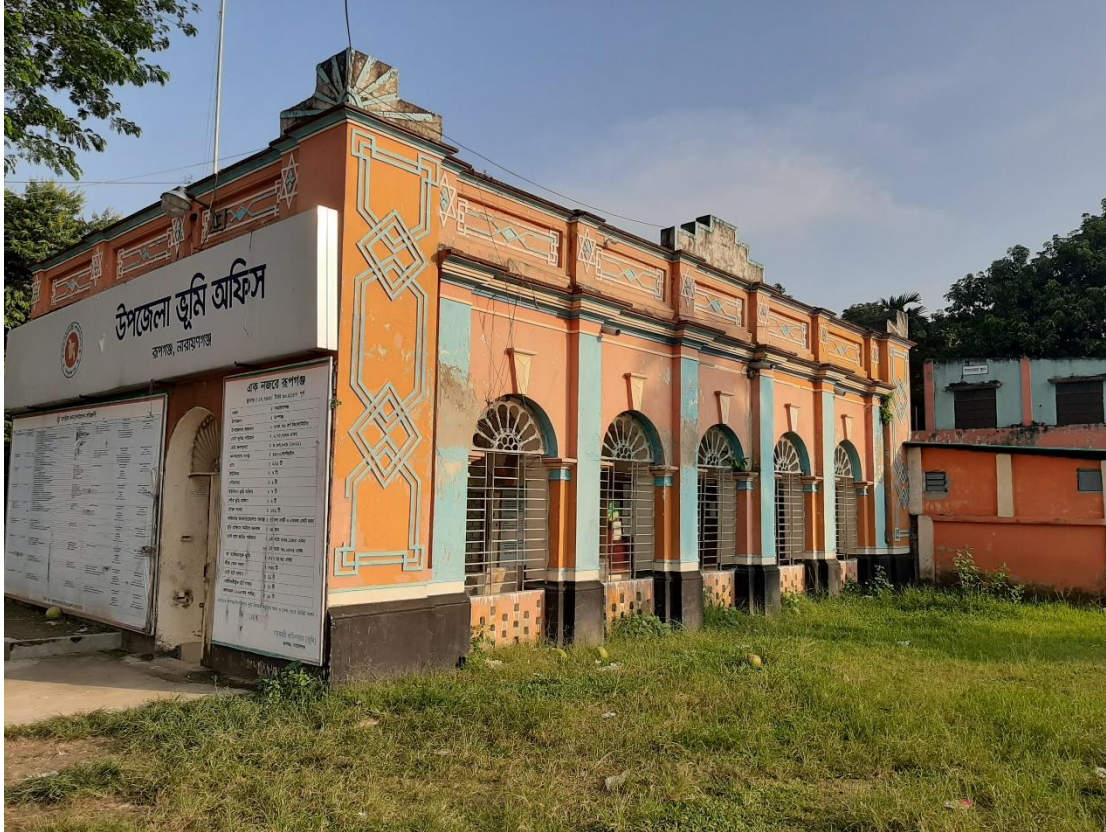
Figure.4.9. Front view of the building.

Possible Cause of Failure: The probable cause of crack due settlement of lime masonry. Probable another cause is undesired changes in the physical properties of the materials due to the presence of water/humidity.

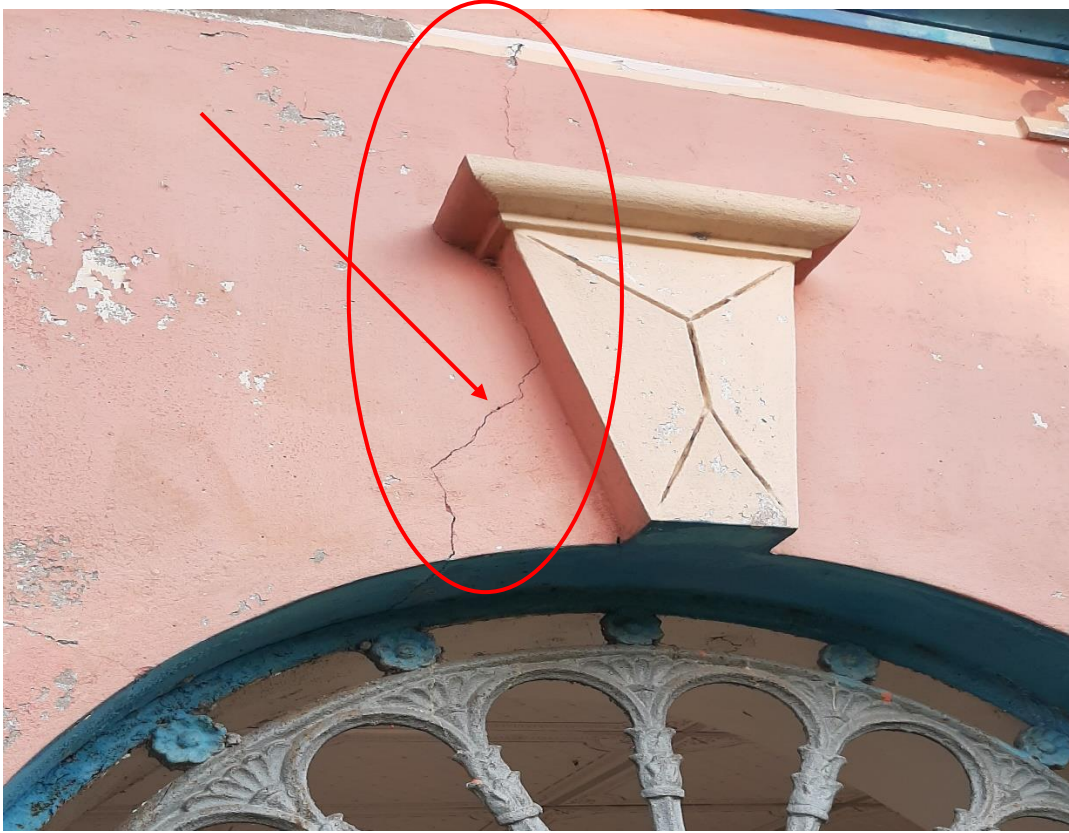
Figure.4.10. crack on due to settlement failure.

A incline/angler crack of wall was observed. The crack even propagated over the lintel.

Kinds of Failure: Settlement failure.

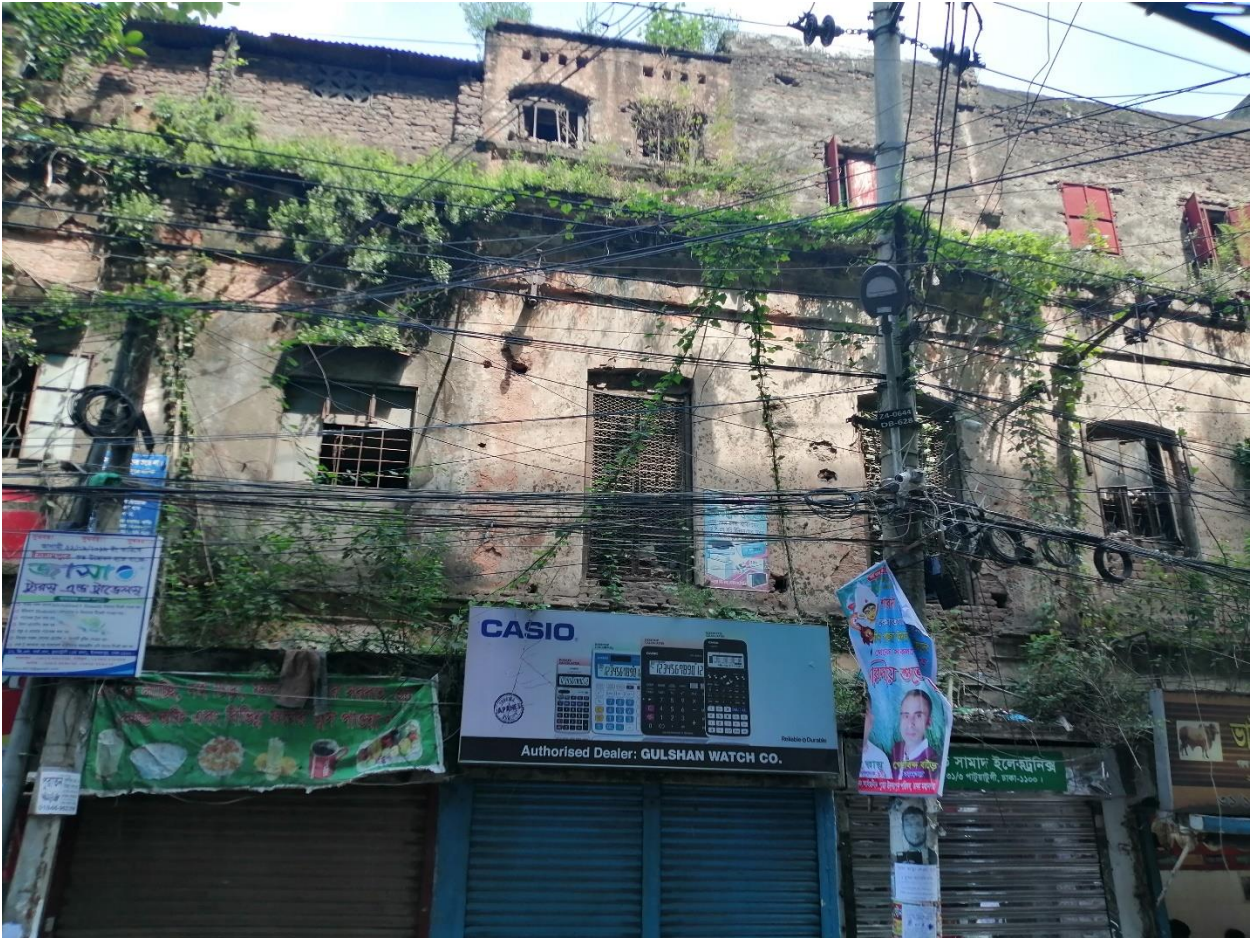
Figure.4.11. Front view of the building.

Possible Cause of Failure: The probable cracking defects in structural masonry due to ageing impact / settlement of masonry. Other Probable cause of the crack due to build new structure over the old structure. Another cause of failure, Ageing and degradation of the materials, in particular rendering systems, due to continuous exposure in the environment.

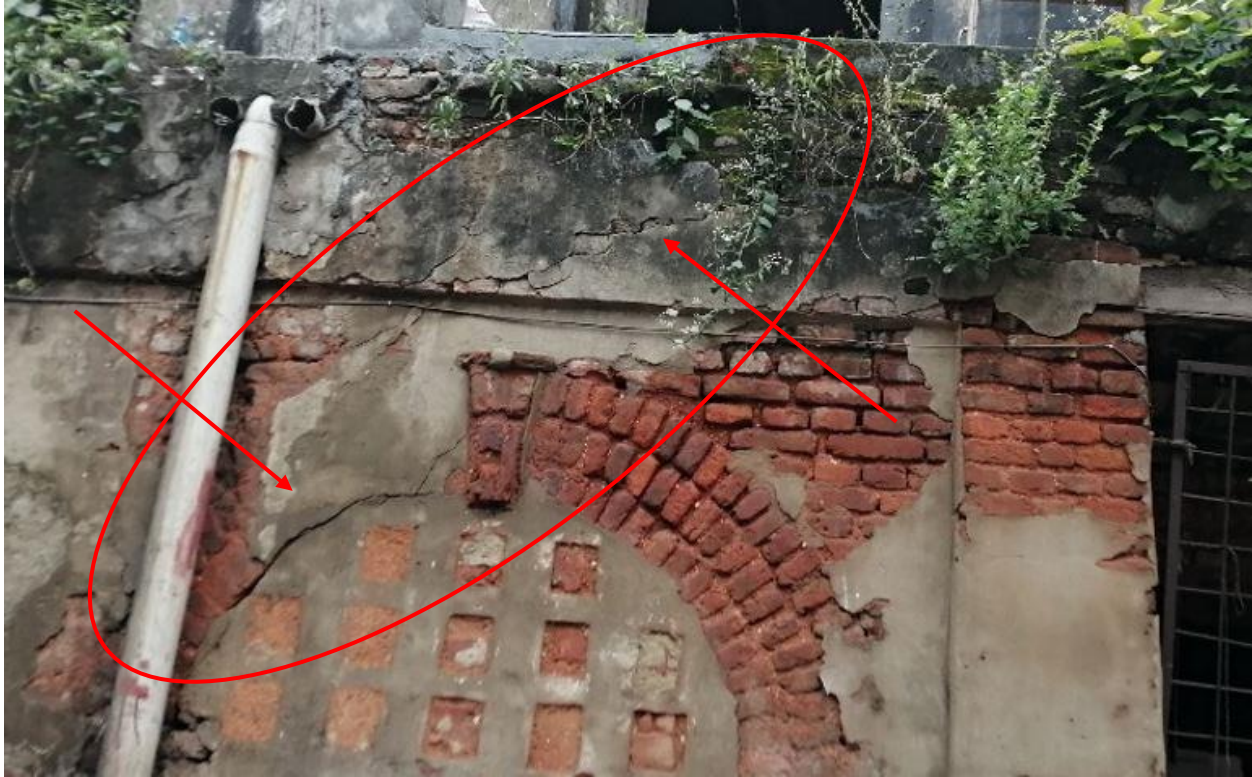
Figure.4.12. Crack on due to ageing impact/ settlement failure.

Observed an incline/angler crack of wall. The crack is almost 45 degree with respect horizontal axis.

Kinds of Failure: Ageing impact /settlement failure.

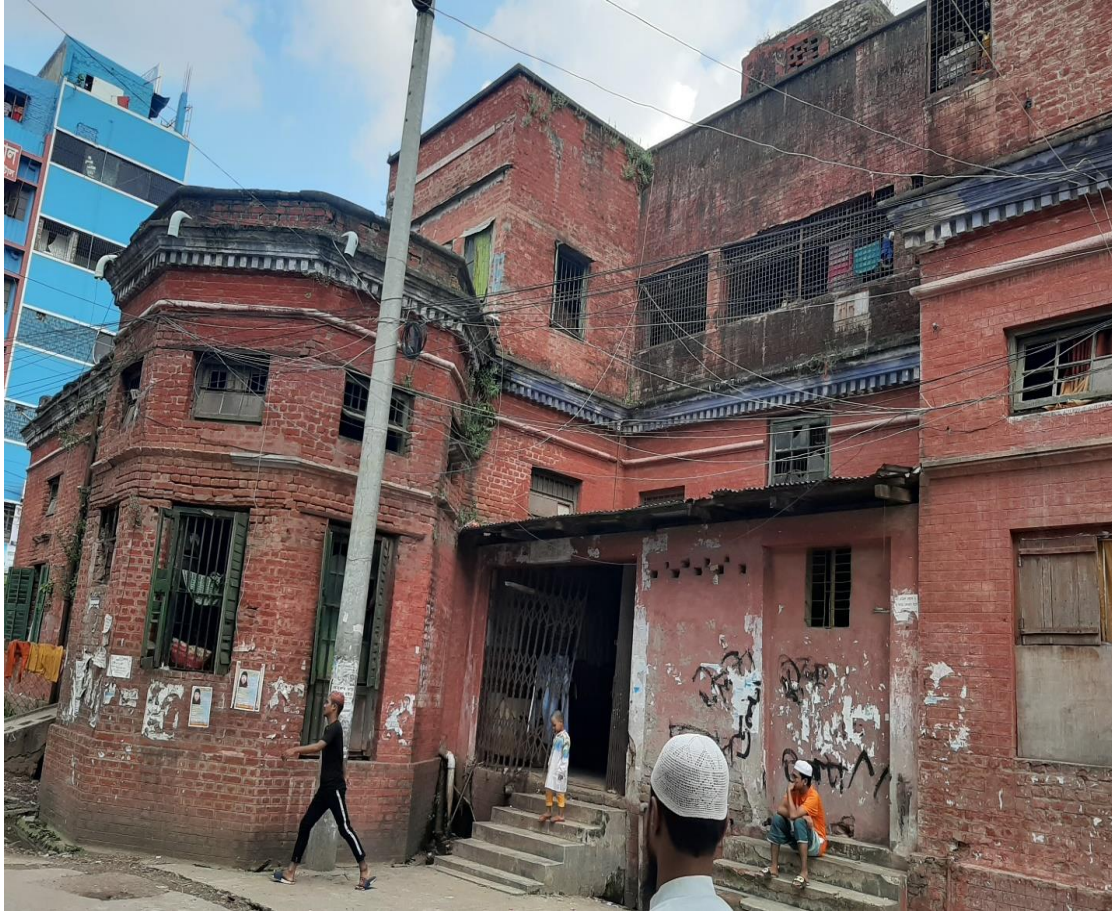
Figure.4.13. Front view of the building.

Possible Cause of Failure: The probable cause of crack due uneven settlement of masonry. Probable another cause is undesired changes in the physical properties of the materials due to the presence of water/humidity.

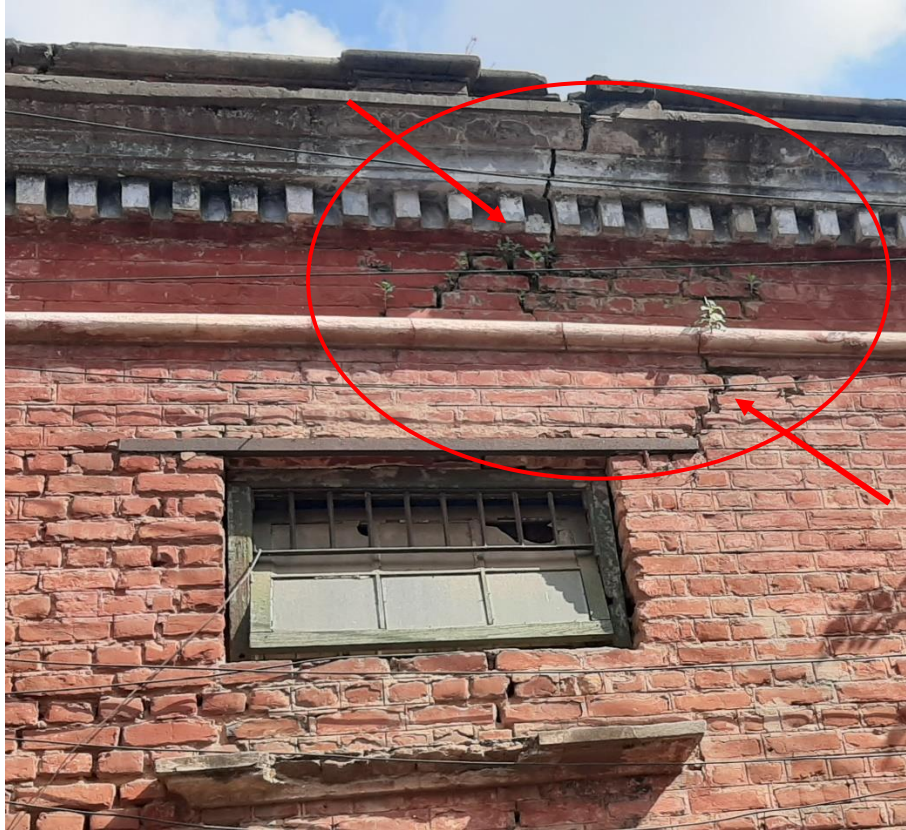
Figure.4.14. Crack on due to settlement failure.

An incline crack of wall was seen. The crack is over the lintel.

Kinds of Failure: Masonry settlement failure.

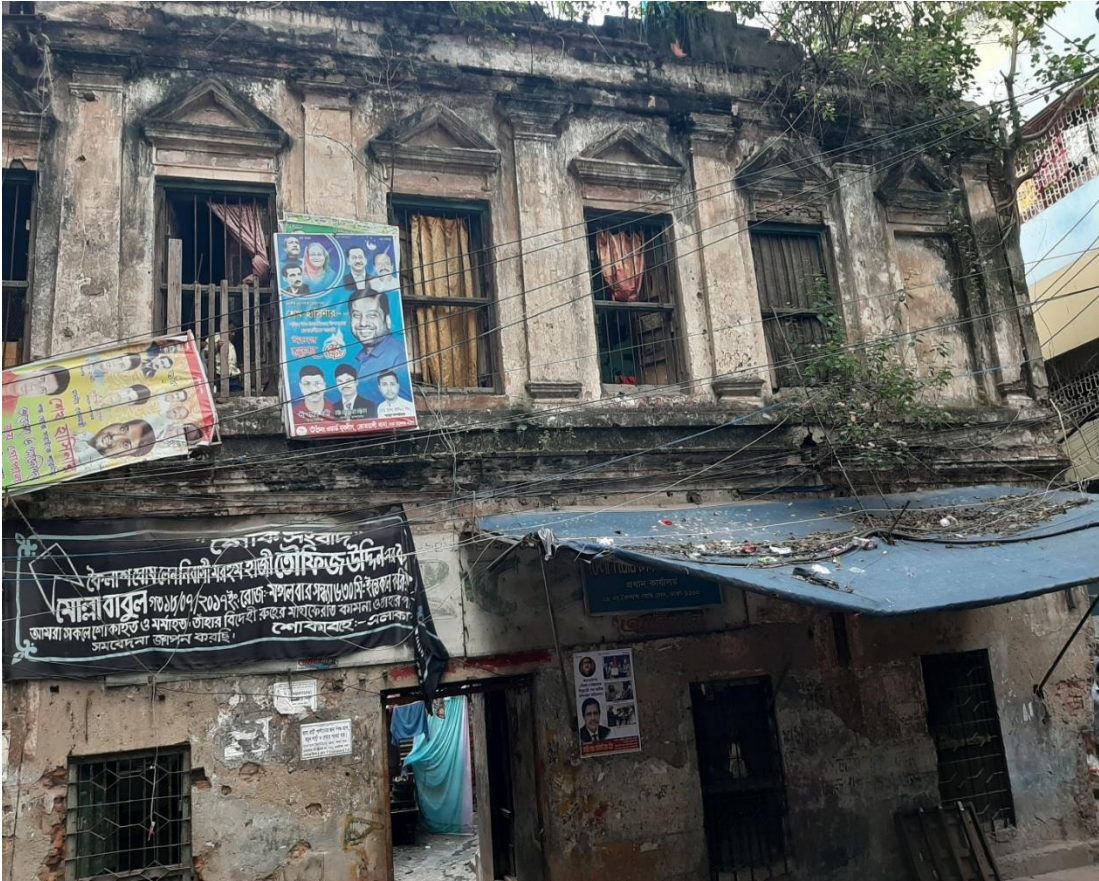
Figure.4.15. Front view of the building.

Possible Cause of Failure: The probable cause of crack due uneven settlement of brick masonry or soil. Another probable cause is the presence of door and window openings in near the crack.

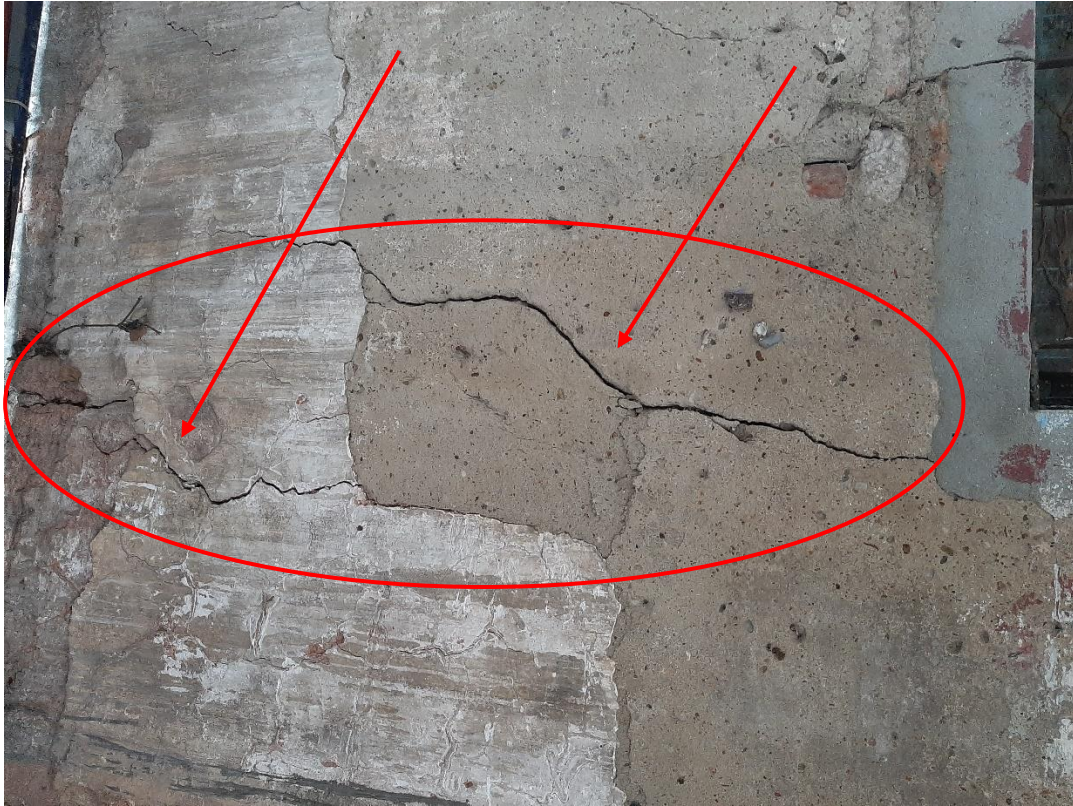
Figure.4.16. Crack on due to the deformation of support.

A horizontal crack was observed. The crack developed for uneven settle of foundation.

Kinds of Failure: Settlement failure.

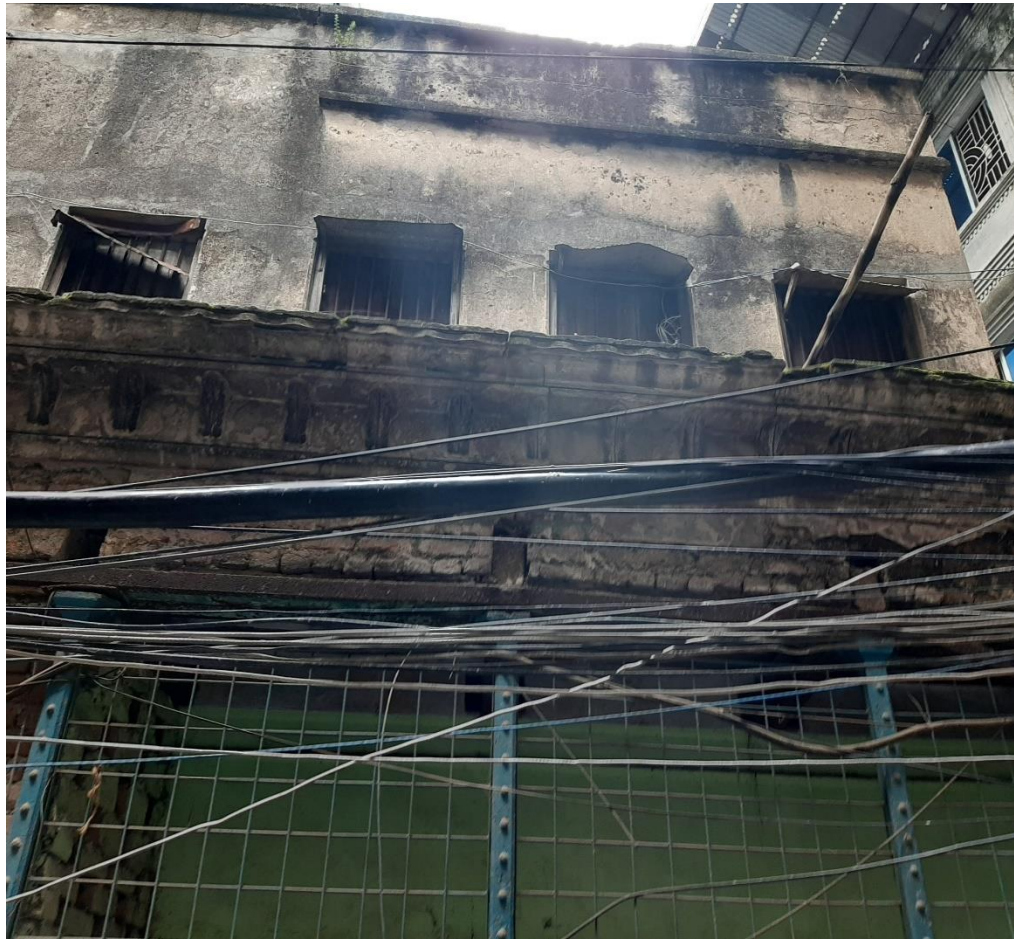
Figure.4.17. Front side view of the building.

Possible Cause of Failure: The probable cracking defects in structural due to masonry settlement. Other Probable cause of the crack due to build new structure over the old structure. Another cause of failure, Ageing and degradation of the materials, in particular rendering systems, due to continuous exposure in the environment.

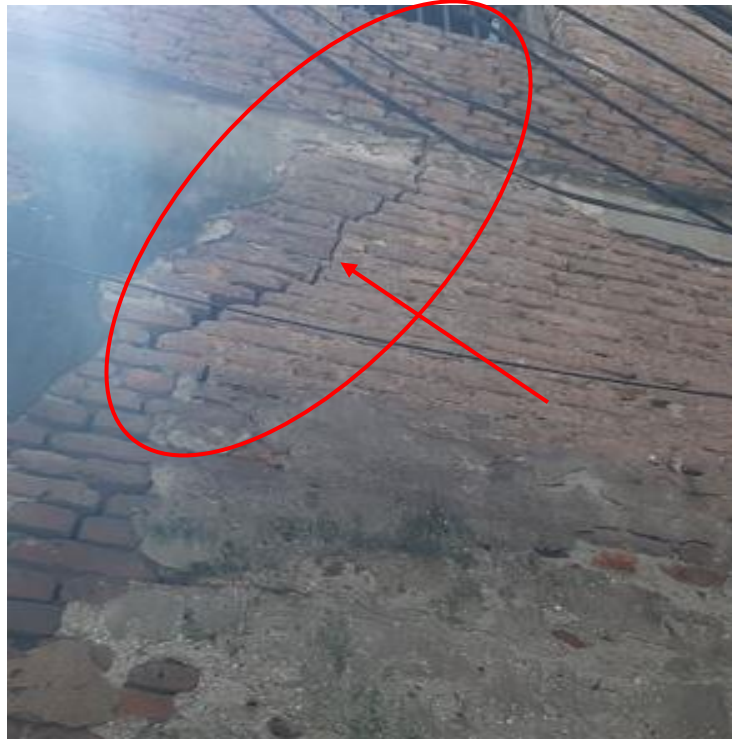
Figure.4.18. Crack on due to the masonry settlement.

Observed an incline/angler crack of wall. The crack is almost 45 degree with respect to horizontal axis.

Kinds of Failure: Masonry settlement failure.

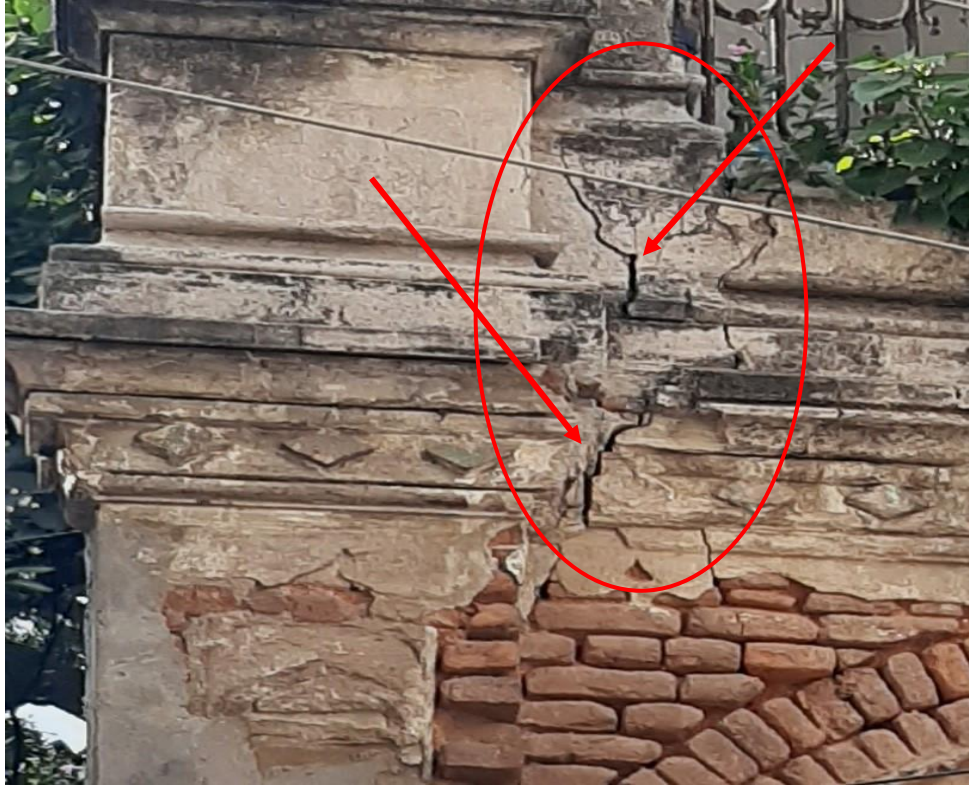
Figure.4.20. Crack on due to the Joint failure/share failure.

Observed joint crack in masonry column and beam.

Kinds of Failure Joint failure/share failure.

Possible Cause of Failure: The probable cause of crack due to weak bonding of mortar in the joint. Other Probable cause of the crack due to design over load on the structure.
