SEISMIC VULNERABILITY ASSESSMENT OF RESIDENTIAL BUILDINGS AT DHAKA CITY, BANGLADESH USING FEMA 154

A thesis submitted to the Department of Civil Engineering in partial fulfillment
for the degree of Bachelor of Science in Civil Engineering

Sonargaon University

Summer-2023

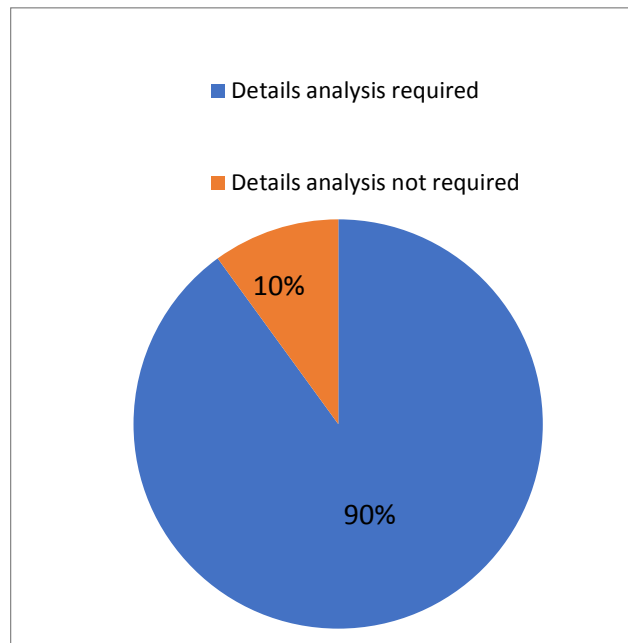
Figure. 4-11: Detailed Evaluation Required

In the present study, the cutoff value of the final structural score is considered as 2.0 which indicates that below this score seismically hazardous and detailed seismic evaluation of the building is required. This study summarized that a total of 30 buildings have scored below cut-off score and the remaining 27 buildings have passed the score. It can be concluded that about 90% of buildings required more detailed investigation to decide the level of actual seismic risk (Fig. 4-11).

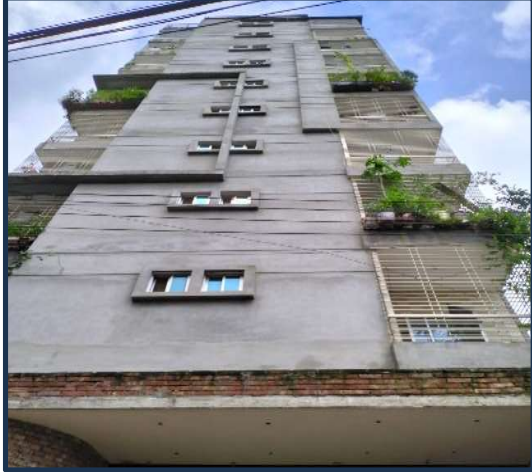
<p><u>PHOTOGRAPH</u></p>

<p>Address: Green Place, Bhuiya Bari, Merul Badda, Dhaka -1212</p> <p>No. Stories: (G+9) Year Built: 2021</p> <p>Screener :</p> <p>Building Name: Green Place</p> <p>Total Floor Area (sq. ft): 2880</p>

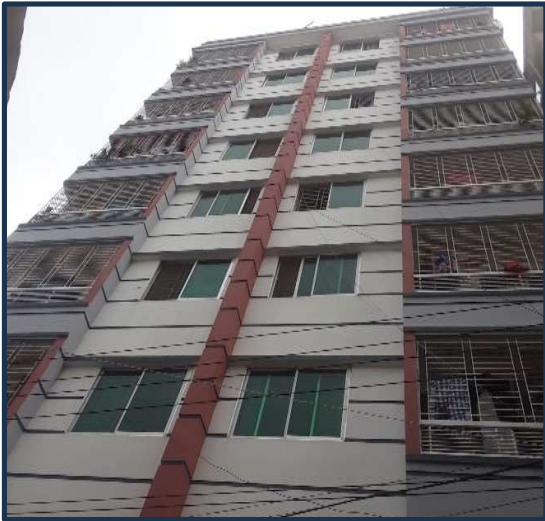
<p>PHOTOGRAPH</p>

<p>Address: Anando Vhabon, Bhuiya Bari More, Merul Badda, Dhaka-1212</p> <p>No. Stories: (G+8) Year Built: 2010</p> <p>Screener :</p> <p>Building Name: Anando Vhabon</p> <p>Total Floor Area (sq. ft): 2800</p> <div style="text-align: center;">

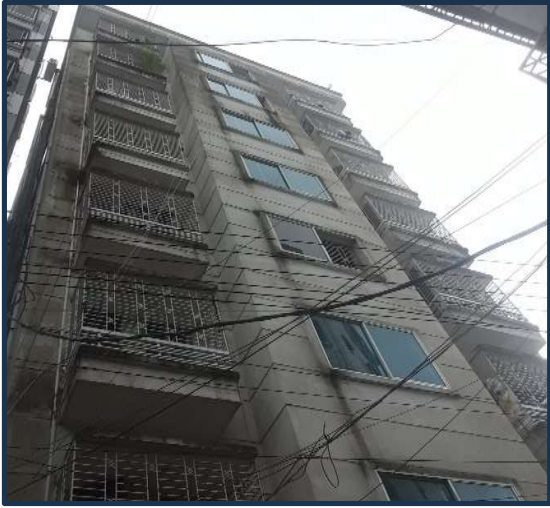
<p>PHOTOGRAPH</p>

<p>Address: Delowan Bhaban, Bhuiya Bari, Merul Badda, Dhaka -1212</p> <p>No. Stories: (G+7) Year Built: 2015</p> <p>Screener :</p> <p>Building Name: Delowan Bhaban</p> <p>Total Floor Area (sq. ft): 2900</p> <div style="text-align: center; margin-top: 20px;">

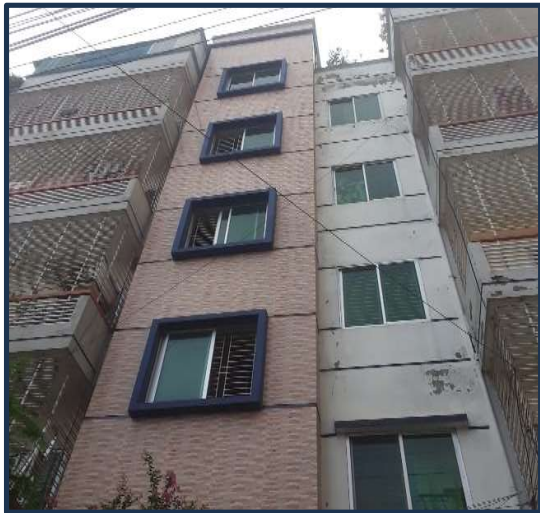
<p><u>PHOTOGRAPH</u></p>

<p>Address: Hoque Villa, Masjid Road, Aftabnagar, Merul Badda, Dhaka -1212</p> <p>No. Stories: (G+5) Year Built: 2012</p> <p>Screener :</p> <p>Building Name: Hoque Villa</p> <p>Total Floor Area (sq. ft): 3600</p> <div style="text-align: center;">

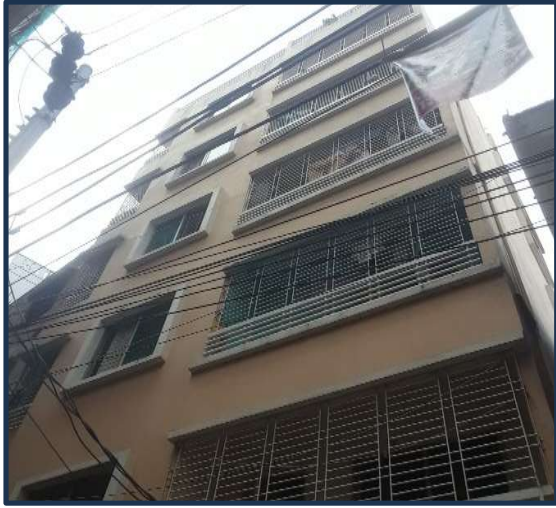
<p><u>PHOTOGRAPH</u></p>

<p>Address: Rafiq Mantion, Bhuya Bari, Merul Badda, Dhaka -1212</p> <p>No. Stories: (G+5) Year Built: 2017</p> <p>Screener :</p> <p>Building Name: Rafiq Mantion</p> <p>Total Floor Area (sq. ft): 1800</p>

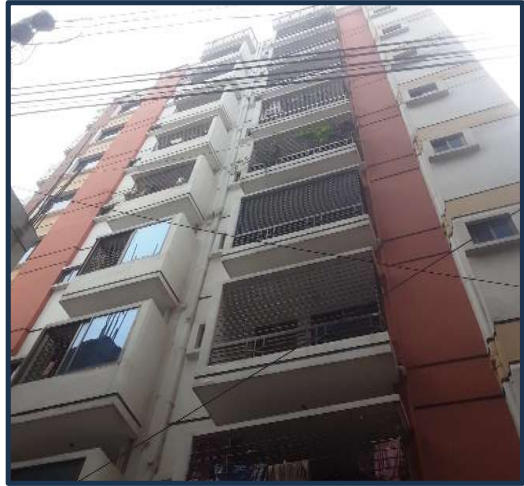
<p>PHOTOGRAPH</p>

Address: Professons Complex, Bhuiya Bari, Merul Badda, Dhaka -1212																																																																																																																																																																																																													
		No. Stories: (G+8)				Year Built: 2012																																																																																																																																																																																																									
		Screener :																																																																																																																																																																																																													
		Building Name: Professons Complex																																																																																																																																																																																																													
		Total Floor Area (sq. ft): 4800

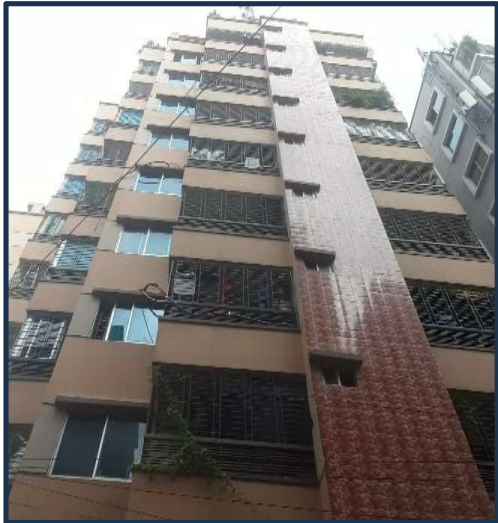
<p>PHOTOGRAPH</p>

<p>Address: Dolon Chapa, Aftab Nagor, Dhaka -1212</p> <p>No. Stories: (G+9) Year Built: 2003</p> <p>Screener :</p> <p>Building Name: Dolon Chapa</p> <p>Total Floor Area (sq. ft): 5500</p>

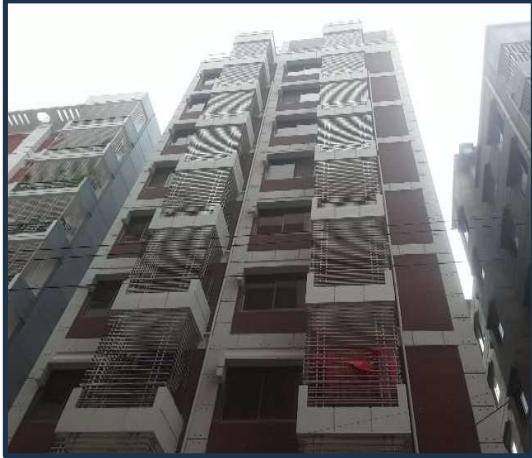
<p><u>PHOTOGRAPH</u></p>

<p>Address: Jannat Villa, Aftabnagar, Dhaka -1212</p> <p>No. Stories: (G+8) Year Built: 2018</p> <p>Screener :</p> <p>Building Name: Jannat Villa</p> <p>Total Floor Area (sq. ft): 2500</p> <div style="text-align: center; margin-top: 20px;">

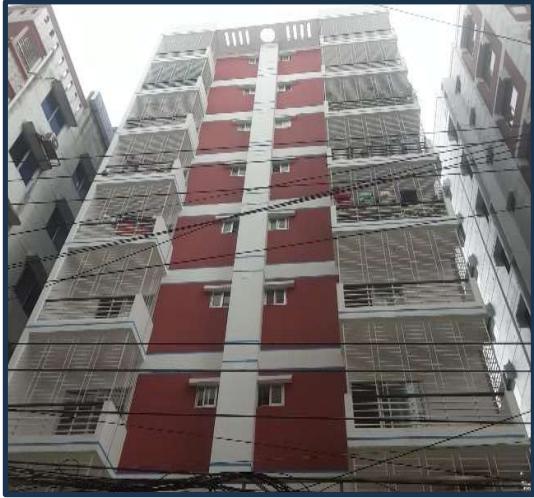
<p><u>PHOTOGRAPH</u></p>

<p>Address: Doyel onchid Garden, Aftabnagor, Dhaka -1212</p> <p>No. Stories: (G+8) Year Built: 2014</p> <p>Screener :</p> <p>Building Name: Doyel onchid Garden</p> <p>Total Floor Area (sq. ft): 2300</p> <div style="text-align: center; margin-top: 20px;">

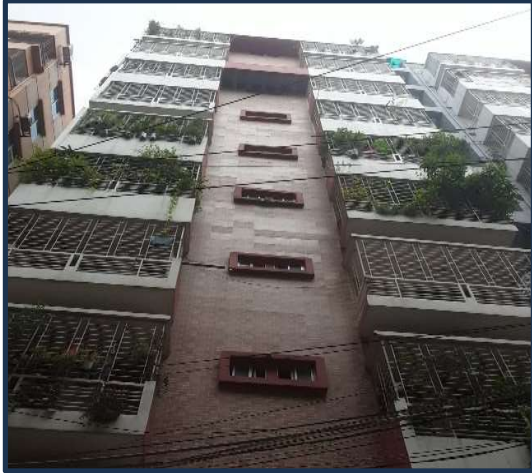
<p><u>PHOTOGRAPH</u></p>

<p>Address: Redion Bhwiya Kanon, Aftabnoger, Dhaka -1212</p> <p>No. Stories: (G+9) Year Built: 2012</p> <p>Screener :</p> <p>Building Name: Redion Bhwiya Kanon</p> <p>Total Floor Area (sq. ft): 3800</p> <div style="text-align: center; margin-top: 20px;">

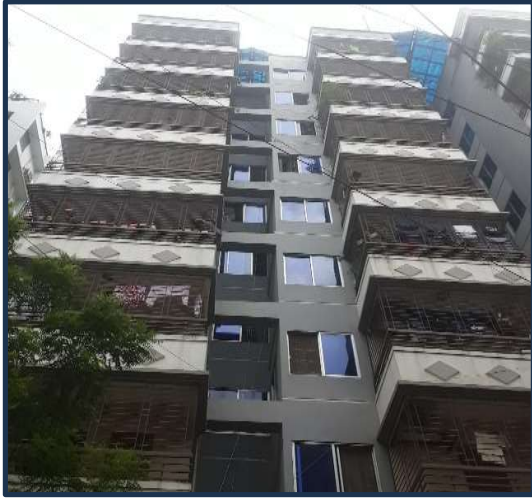
<p><u>PHOTOGRAPH</u></p>

<p>Address: Safiya Bhaban, Aftabnagor, Dhaka -1212</p> <p>No. Stories: (G+8) Year Built: 2012</p> <p>Screener :</p> <p>Building Name: Safiya Bhaban</p> <p>Total Floor Area (sq. ft): 3800</p> <div style="text-align: center;">

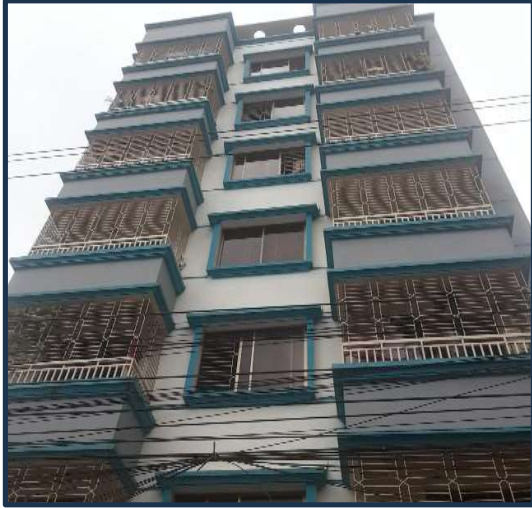
<p><u>PHOTOGRAPH</u></p>

<p>Address: Pinkey Villa, Aftabnagar, Dhaka -1212</p> <p>No. Stories: (G+7) Year Built: 2010</p> <p>Screener :</p> <p>Building: Pinkey Villa, Bhaban</p> <p>Total Floor Area (sq. ft): 2900</p> <div style="text-align: center;">

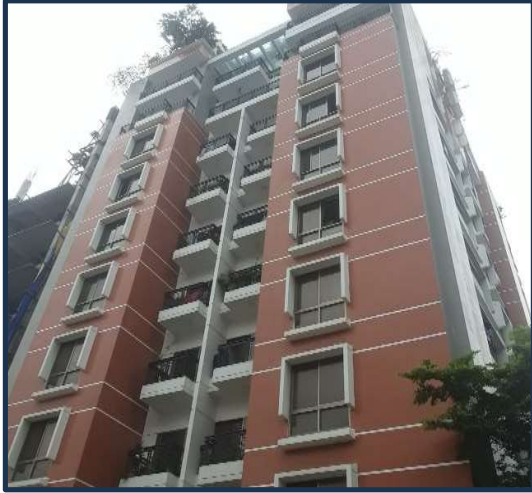
<p>PHOTOGRAPH</p>

<p>Address: Tamanna Mantion, Aftabnagar, Dhaka -1212</p> <p>No. Stories: (G+7) Year Built: 2010</p> <p>Screener :</p> <p>Building: Tamanna Mantion</p> <p>Total Floor Area (sq. ft): 2900</p> <div style="text-align: center; margin-top: 20px;">   <p>PLAN</p> </div>										
OCCUPANCY			Number of Persons		SOIL TYPE						FALLING HAZARDS				
Assembly	Govt.	Office			A	B	C	D	E	F					
Commercial	Historic	Residential	0-10	11-100	Hard	Avg.	Dense	Stiff	Soft	Poor	Unrein-forced	Parapets	Cladding	Other	
Emergency Service	Industrial	School	101-1000	1000+	Rock	Rock	Soil	Soil	Soil	Soil	Chimneys				
BUILDING TYPE	W1	W2	S1 (MRF)	S2 (BR)	S3 (LM)	S4 (RCSW)	S5 (URMINF)	C1 (MRF)	C2 (SW)	C3 (URMINF)	PC1 (TU)	PC2	RM1 (FD)	RM2 (RD)	URM
Basic Score	4.4	3.8	2.8	3.0	3.2	2.8	2.0	2.5	2.8	1.6	2.6	2.4	2.8	2.8	1.8
Mid Rise (4 to 7 Stories)	N/A	N/A	+0.2	+0.4	N/A	+0.4	+0.4	+0.4	+0.4	+0.2	N/A	+0.2	+0.4	+0.4	-0.4

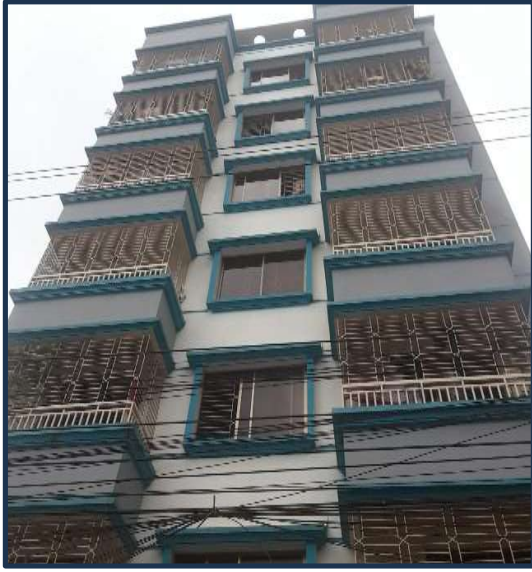
<p><u>PHOTOGRAPH</u></p>

<p>Address: Joshim Tower, Aftabnagar, Dhaka -1212</p> <p>No. Stories: (G+6) Year Built: 2018</p> <p>Screener :</p> <p>Building: Joshim Tower</p> <p>Total Floor Area (sq. ft): 2200</p>

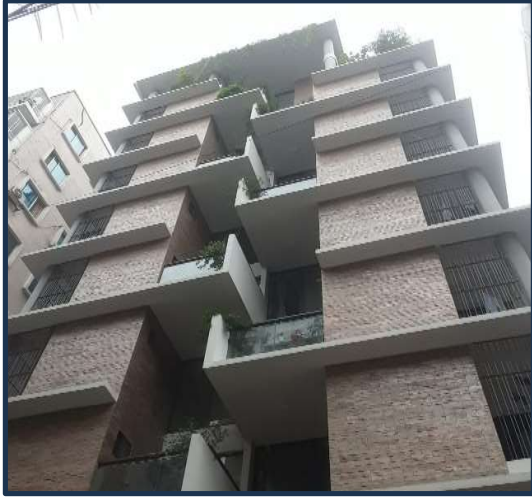
<p><u>PHOTOGRAPH</u></p>

<p>Address: Aftab Mantion, Aftabnagor, Dhaka -1212</p> <p>No. Stories: (G+8) Year Built: 2018</p> <p>Screener:</p> <p>Building: Aftab Mantion</p> <p>Total Floor Area (sq. ft): 4000</p> <div style="text-align: center;">

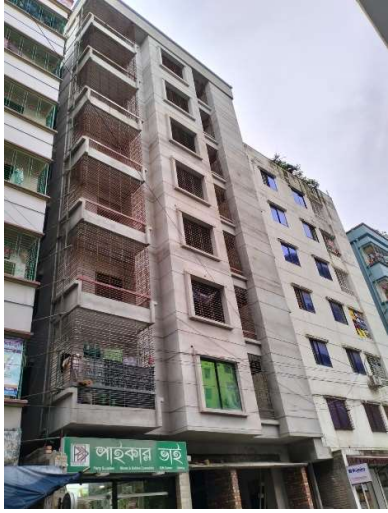
<p><u>PHOTOGRAPH</u></p>

<p>Address: Block-G, Road-1, Plot-58, Banasree, Dhaka.</p> <p>No. Stories: 8 Year Built: 2015</p> <p>Screener :</p> <p>Building Name: Momin House</p> <p>Total Floor Area (sq. ft) : 1800</p> <div style="text-align: center;">

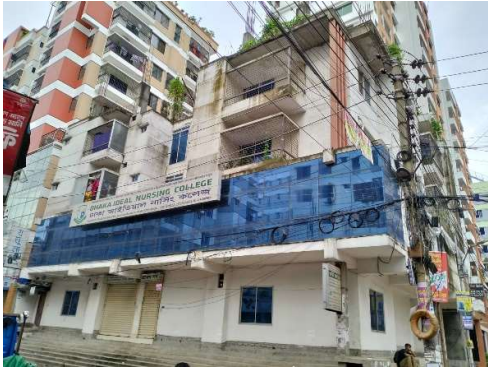
<p>PHOTOGRAPH</p>

<p>Address: Block-H, Road-1, Plot-1, Banasree, Dhaka.</p> <p>No. Stories: 4 Year Built: 2008</p> <p>Screener :</p> <p>Building Name: Dhaka Ideal Nursing College</p> <p>Total Floor Area (sq. ft) : 2300</p> <div style="text-align: center;">

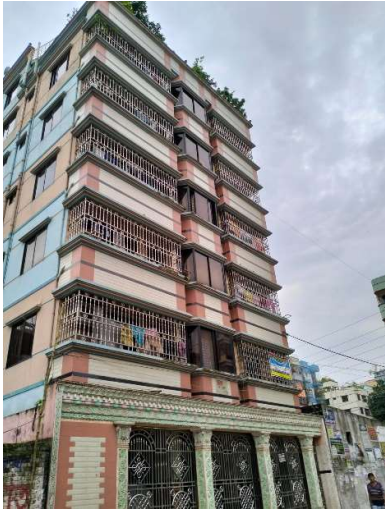
<p><u>PHOTOGRAPH</u></p>

<p>Address: Block-M, Road-13, Plot-23, Banasree, Dhaka.</p> <p>No. Stories: 6 Year Built : 2010</p> <p>Screener :</p> <p>Building Name: Hamim House</p> <p>Total Floor Area (sq. ft) : 2000</p> <div style="text-align: center; margin-top: 20px;">

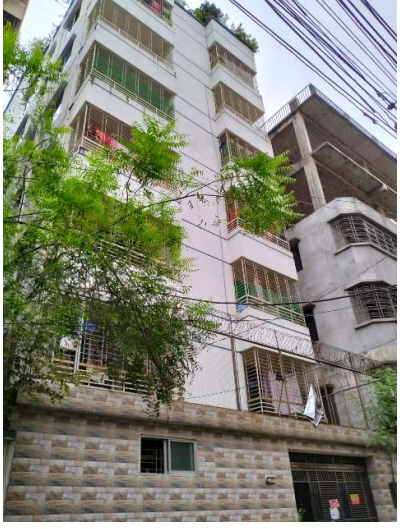
<p>PHOTOGRAPH</p>

<p>Address: Block-G, Road-1, Plot-54, Banasree, Dhaka.</p> <p>No. Stories: 7 Year Built : 2019</p> <p>Screener :</p> <p>Building Name: Sofiq House</p> <p>Total Floor Area (sq. ft) : 2000</p> <div style="text-align: center; margin-top: 20px;">

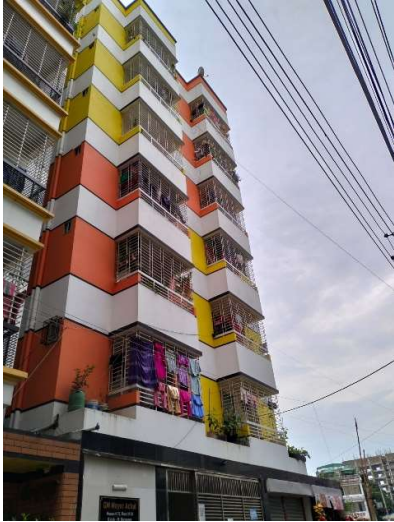
<p>PHOTOGRAPH</p>

Address: Block-M, Road-8, Plot-35, Banasree, Dhaka.	
	No. Stories: 7	Year Built : 2012
	Screener :	
	Building Name: G.M Mayer Achol	
	Total Floor Area (sq. ft) : 1900
