# **ANALYSIS OF FOOTPATH SERVICE QUALITY FROM BIJOY SARANI TO NEW MARKET**

A thesis submitted to the Department of Civil Engineering in partial fulfillment for the degree of Bachelor of Science in Civil Engineering.

## **ABSTRACT**

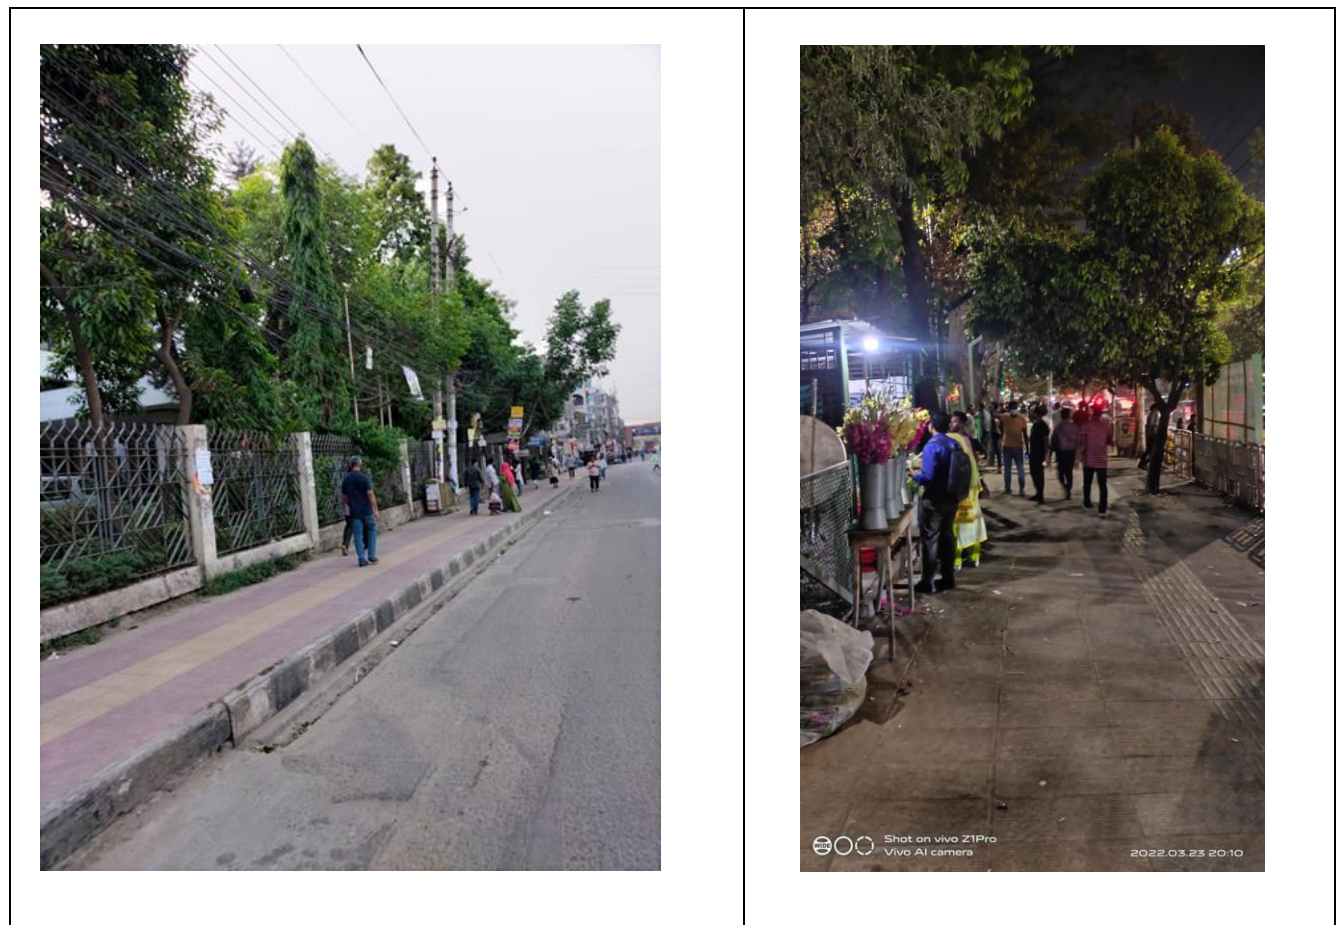
Figure 3-10. During reconnaissance survey

A part of Dhaka city Bijoy sarani to New market is selected as our study area then a reconnaissance survey was conducted to decide the working steps and methodology. At first for this survey we are visited all the six major points to visualize the field condition and decide how the surveys will be conducted. From all of the six points we collected data with approach that we considered every point as a center of circle with a radius of 100 meter. Different age with different quality of people such as consideration of occupation or other activity we selected pedestrian to collect our data. In short time of six day we conducted Reconnaissance survey when sometimes travelled by motor bike and maximum time by walking through footpath.

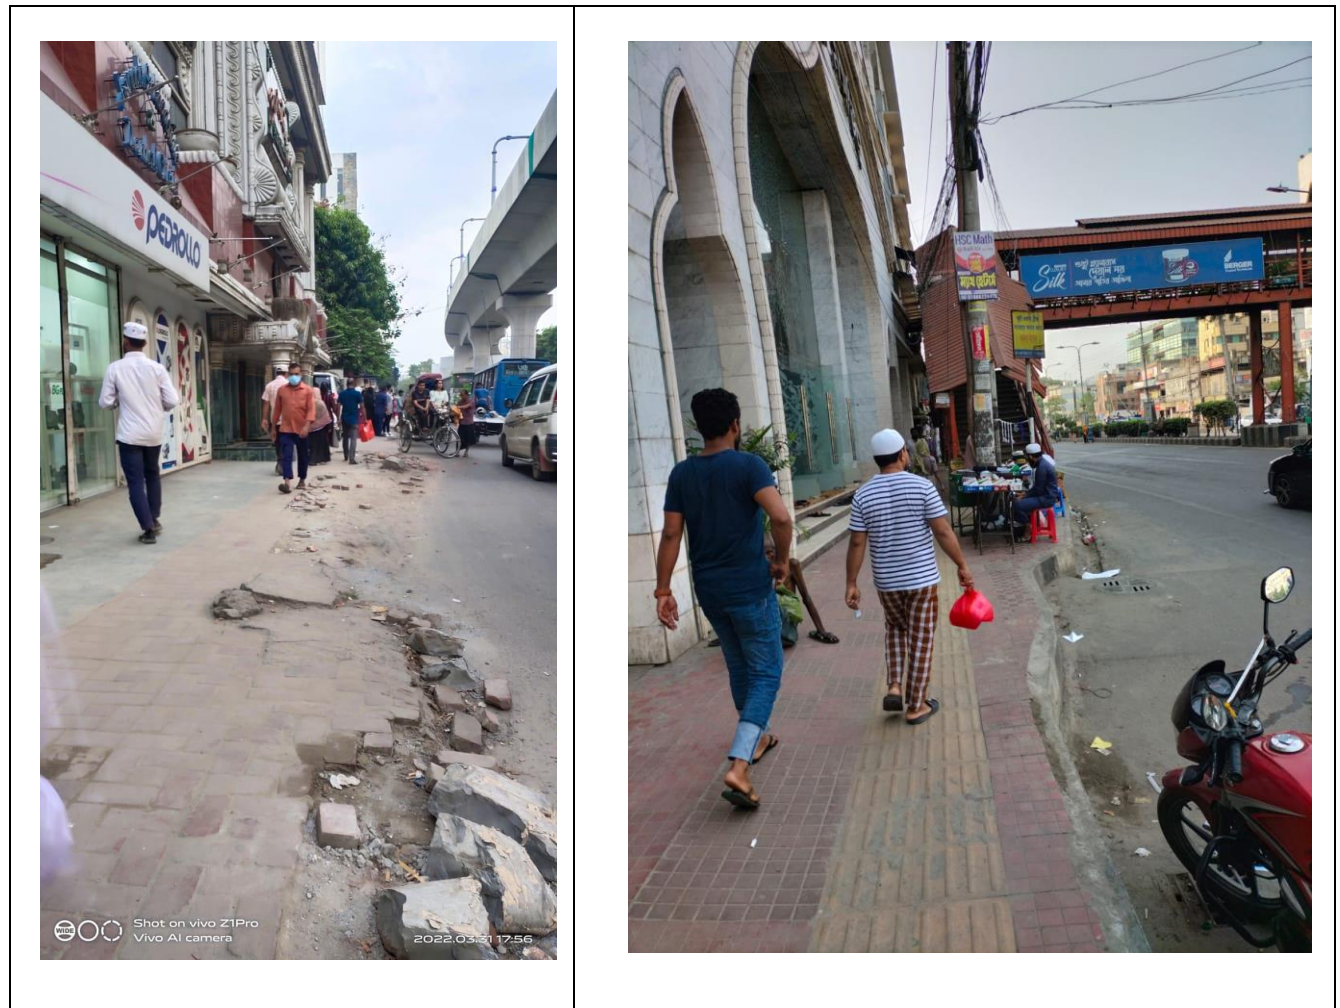
Figure 3-12. During footpath condition survey

In this survey footpath condition of this root of Dhaka city is measured. We collected footpath condition data with variety of categories. The selected points around 100m we collected footpath condition data physically. From Bijoy Sarani to New market we also observed total area by motor bike for looking the footpath condition.

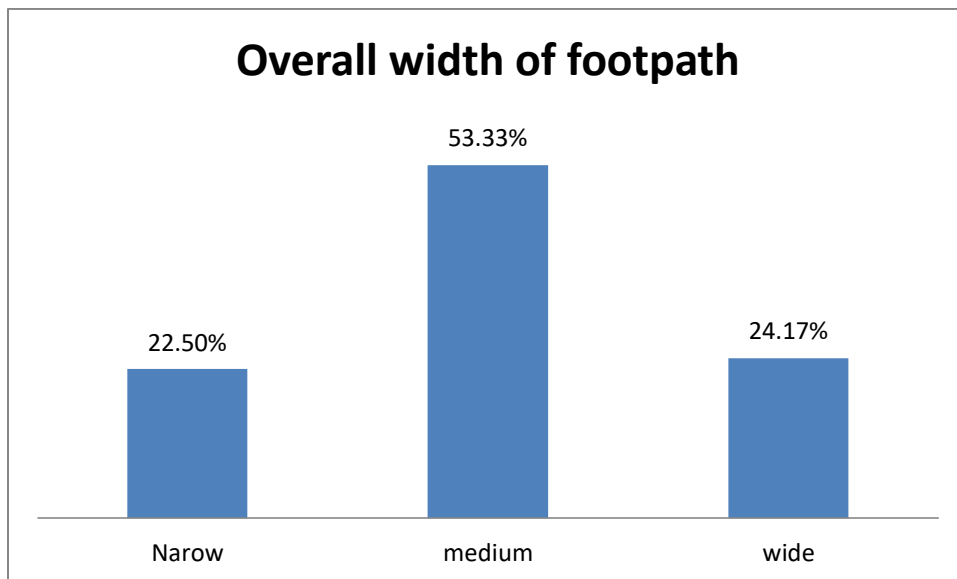
**Figure 4-16. Overall width of footpath**

From collected data it shows that width of footpath is considered as medium by 53.33% people where 22.50% people say it is narrow and 24.17% people said wide. Because of the range medium and narrow people are not so satisfied about footpath width.

The width of footpath at Farmgate, Panthapath, and Newmarket point are narrow. It needs to improve as wide more in future. There is no height of footpath at Bijoy Sarani, Farmgate, Newmarket. So, provide a footpath height along these roads. It also needs to improve height of footpath at these points. There are many barriers on footpath in every point. So early needs to provide a free passageway for pedestrian. Cleanliness level is poor condition at all points so take necessary steps to clean footpath through of this city corporation. Surface condition is also in medium condition at all points so take as steps to improve it. There so many vending activities, bicycle and motorcycle in all points are seen so need to improve this situation by taken steps city corporation authority. Safety and security condition in this study area is not so strong so it needs to be developing by law laying agencies.

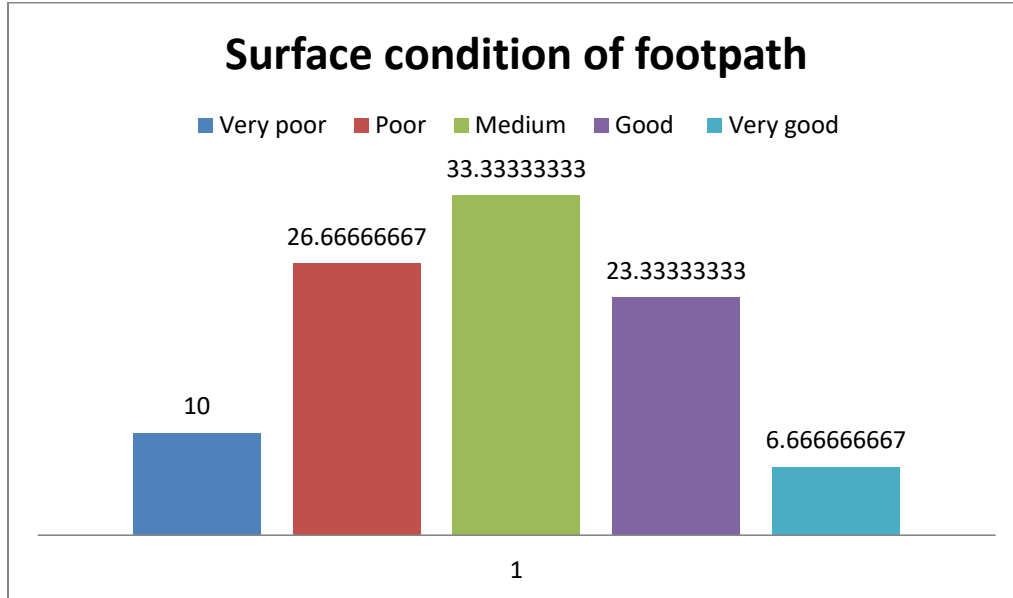
Figure 4-17. Surface condition of footpath

This chart shows that maximum value 33.33% is medium. Because of footpath surface condition is not so good enough in this area. Also for this reason 26.67% is poor. 23.33% said good and 6.67% very good for ceramic tiles surface. Here 10% very poor because surface condition is not enough good as eastern country.

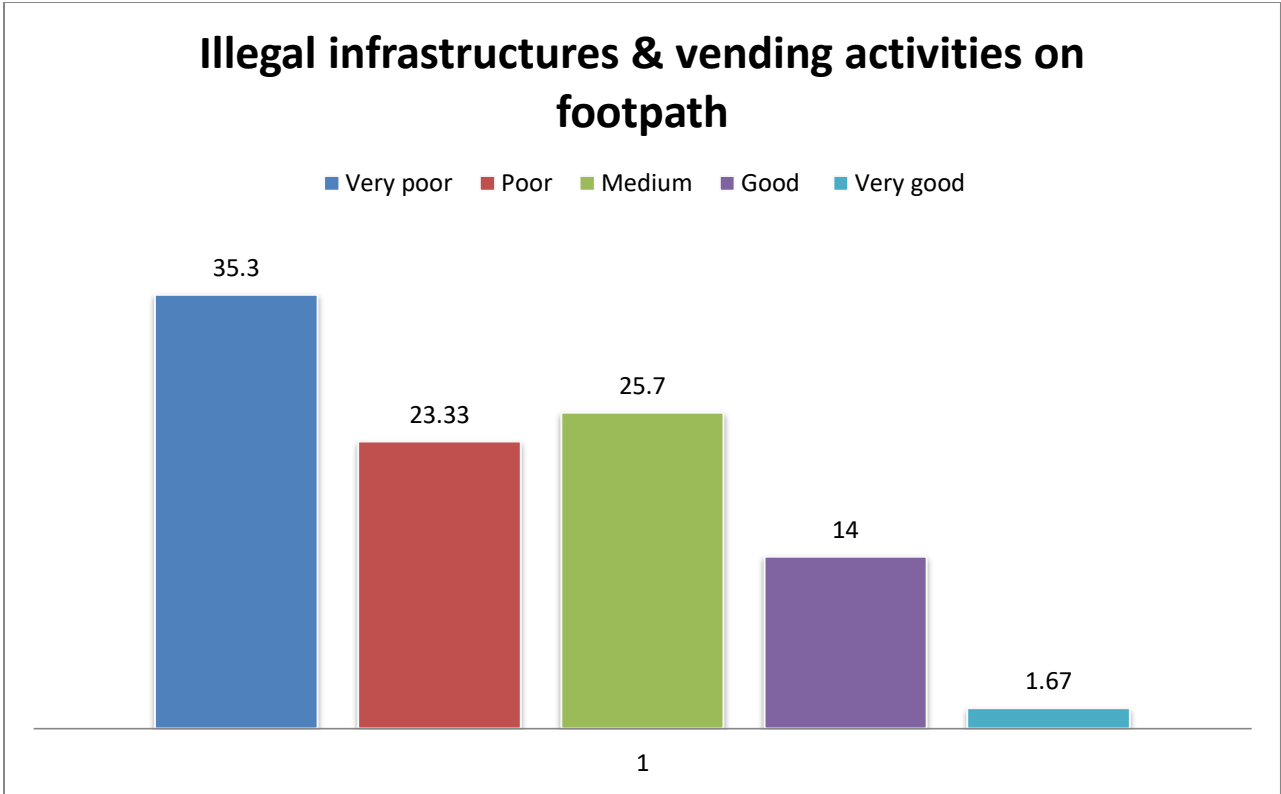
**Figure 4-18. Illegal infrastructure on footpath**

From collected data figure shows that illegal infrastructures on footpath is around good and medium. Values are 1.67% very poor, 23.33% poor, 35% medium, 38.33% good & 1.67% very good respectively. Very poor condition indicates there is a lot of illegal infrastructures and vending activities on footpath. In different places we have seen illegal infrastructures such as shop, building part etc.

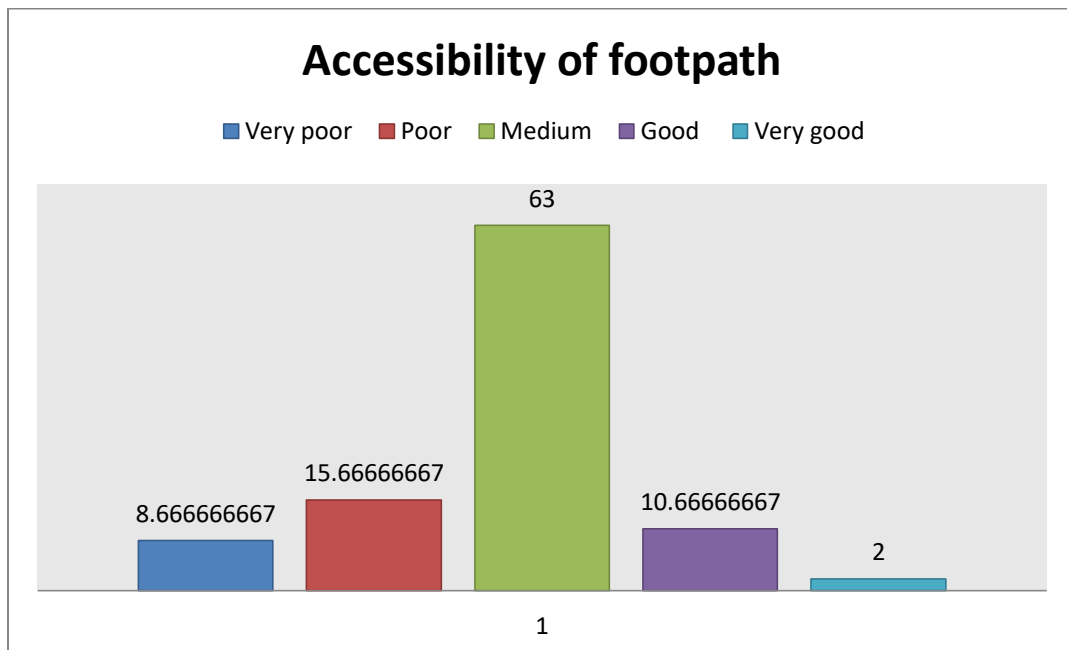
**Figure 4-22. Accessibility of footpath**

This chart shows that accessibility is maximum 63% medium, 15.67% poor, 8.67% very poor, 10.67% good and 2% very good. In this area accessibility is medium because in maximum places fence is absent.

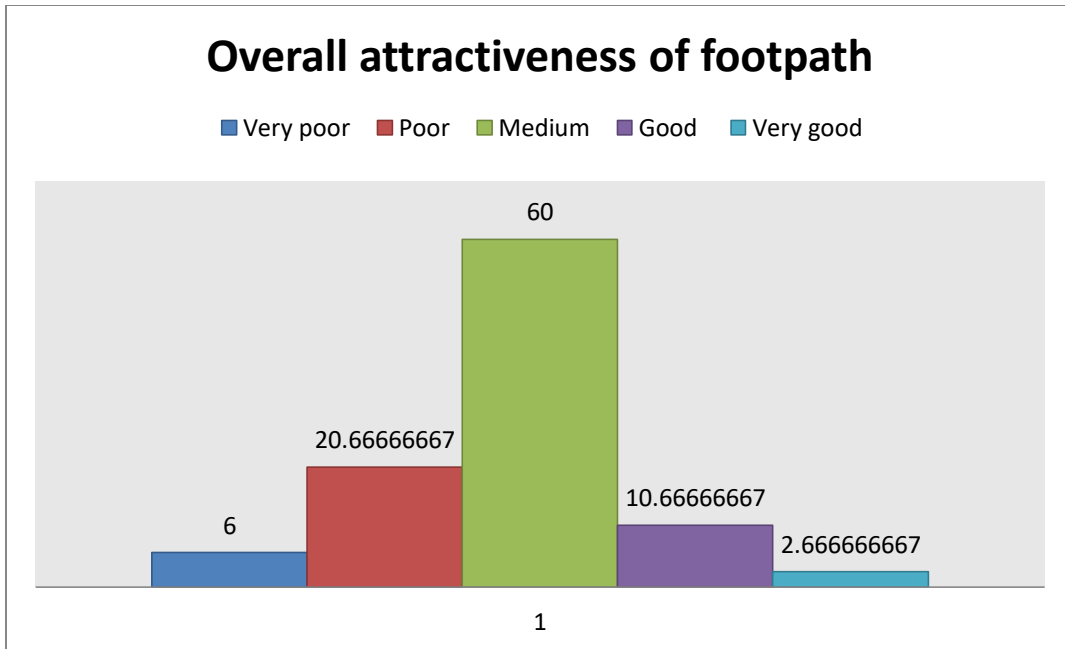
**Figure 4-30. Overall attractiveness of footpath**

Overall attractiveness of footpath in this area is about medium because of 60% rating is medium and 20.67% is poor and 6% is very poor. In some point of this are the attractiveness is too high for the rating 5% good and 1.33% very good.

Attractiveness of footpath in this area is also medium condition.
